**NOTICE AND AGENDA  
Regular Board Meeting  
Sanitary District No. 5 of Marin County  
Thursday, March 18, 2021**

# Collection System Master Plan

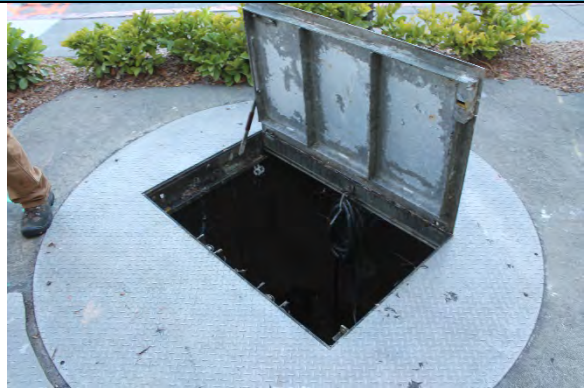
Tiburon 6 Lift Station	
  <p>Lift station in good to fair condition.</p>

<p>Wet well access hatch in fair condition.</p>
  <p>Wet well concrete in poor condition with exposed aggregate and H<sub>2</sub>S attack.</p>	  <p>Electrical and I&amp;C upgraded in 2018 and is in very good condition.</p>

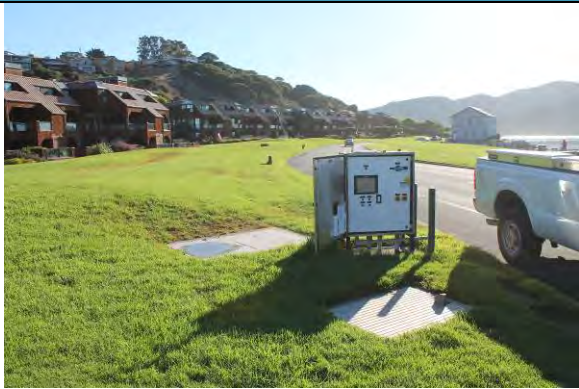
Tiburon 9 Lift Station

<p>Lift station in fair to poor condition. There are no access issues.</p>

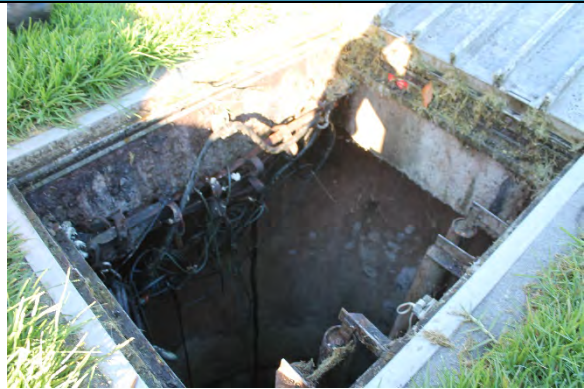
<p>Wet well hatch in fair condition.</p>

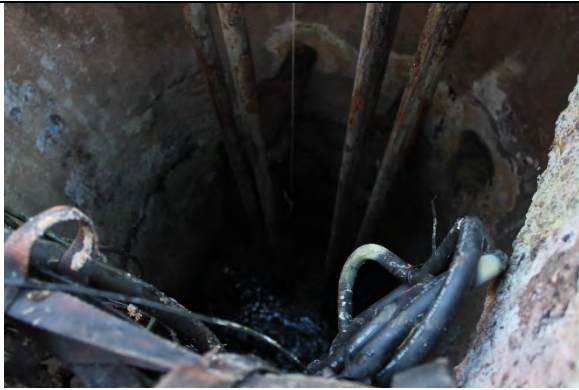
<p>Wet well concrete with exposed aggregate and H<sub>2</sub>S corrosion and in poor condition.</p>

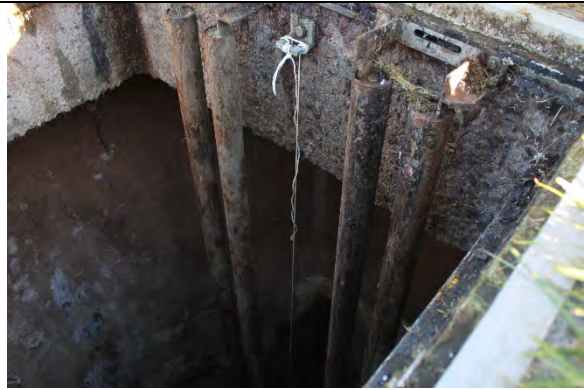
<p>Wet well upper concrete cylinder sections leaning toward shoreline. Offset cylinders show evidence of sealing. Submersible pumps are difficult to remove because of leaning.</p>

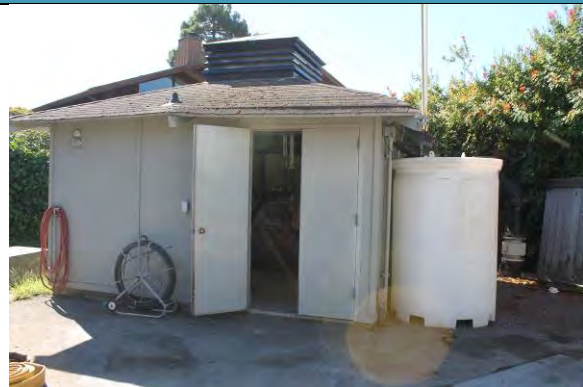
Lift station building in fair to poor condition.

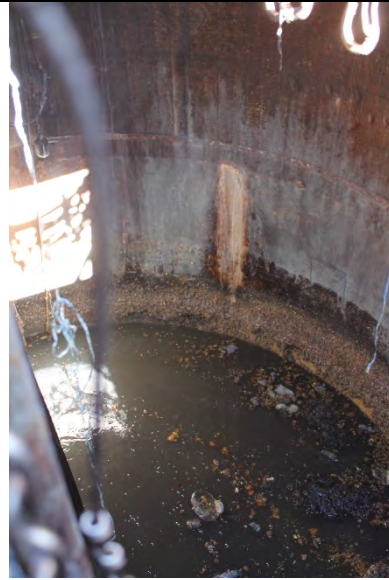
Wet well lined with membrane sealant. It was reported that the membrane is delaminating near the floor. Heavy FOG exhibited during inspection.

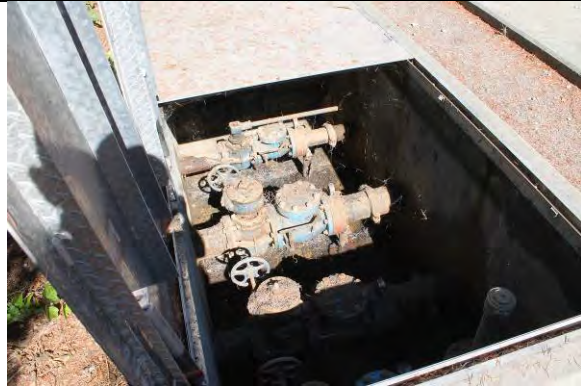
Check and insulation valves reported to be in fair to poor condition.

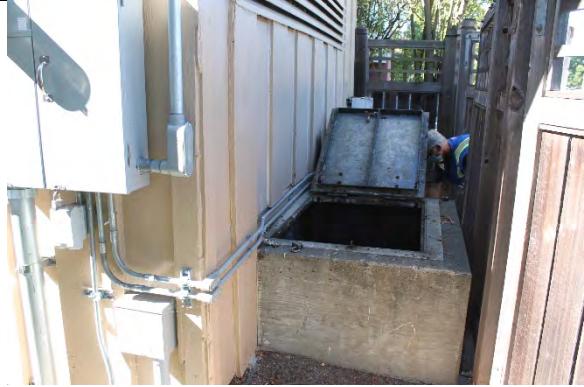
Belvedere 2 Lift Station

Lift station in fair condition. No access issues.	Access hatches to wet well and in fair condition.

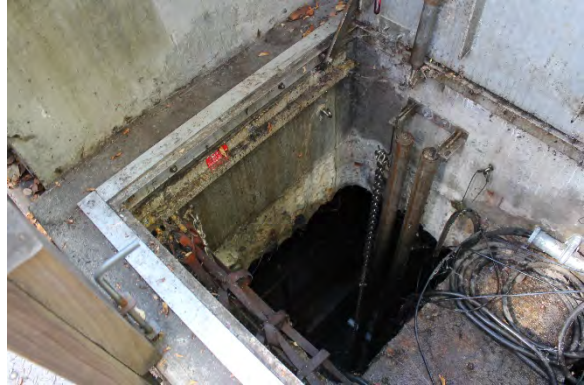
Wet well in fair condition and appeared to be coated with coal tar.	Wet well at access hatch experiencing exposed aggregate and H <sub>2</sub> S corrosion.

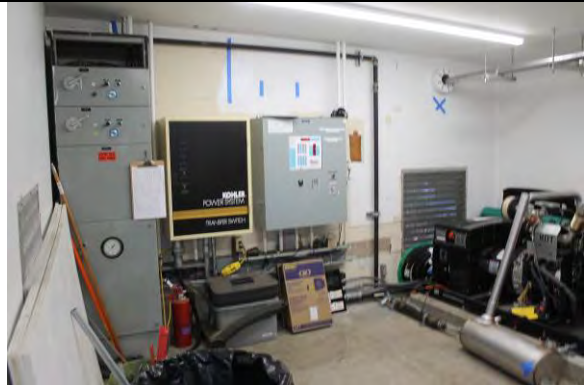
Wet well at access hatch experiencing exposed aggregate and H <sub>2</sub> S corrosion.	Electrical, I&C, and automatic transfer switch are being upgraded during the time of the inspection.

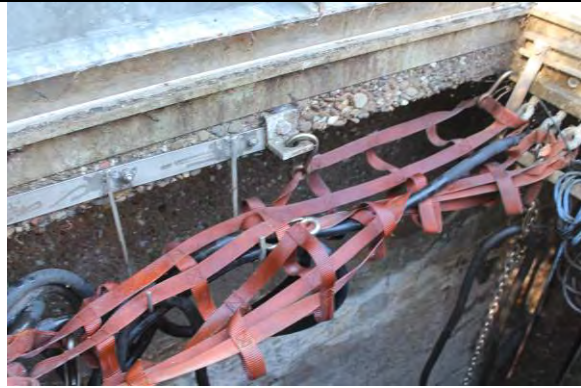
Wet well concrete in poor condition and exhibiting exposed aggregate and H<sub>2</sub>S corrosion.

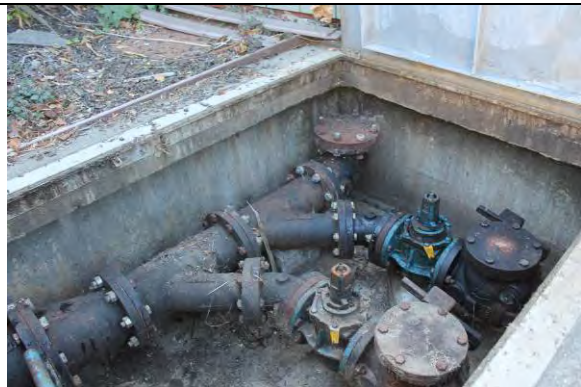
Valve vault concrete and hatches in fair condition. Isolation and check valves are in fair to poor condition.

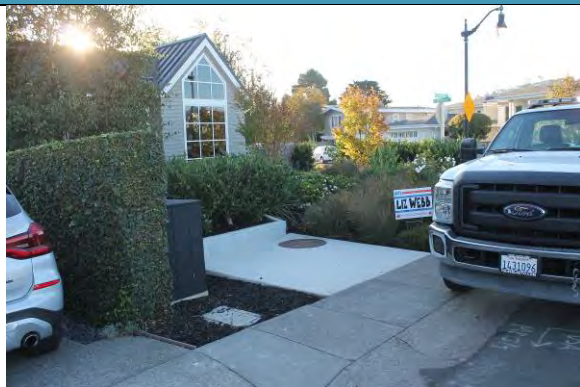
Belvedere 5 Lift Station

Lift station in fair to poor condition. No access issues.

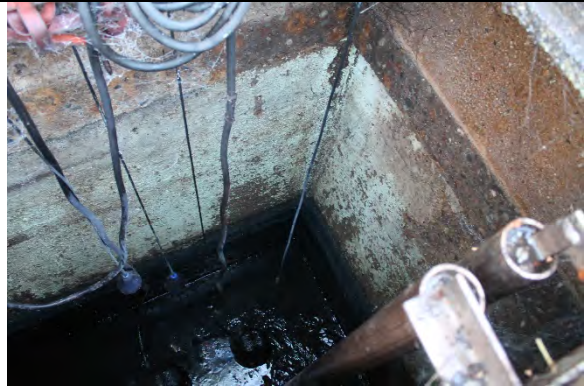
Wet well concrete in poor condition and exhibiting exposed aggregate and H<sub>2</sub>S corrosion. Previously painted.

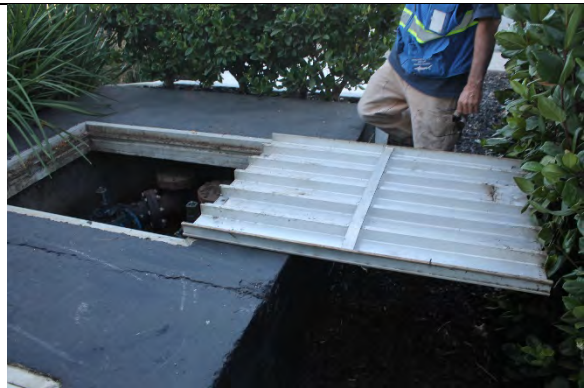
Valve vault in fair condition.

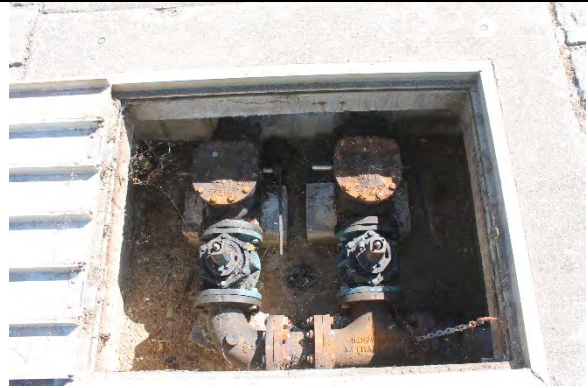
Isolation and check valves in fair and poor condition, respectively. Check valve issues reported.

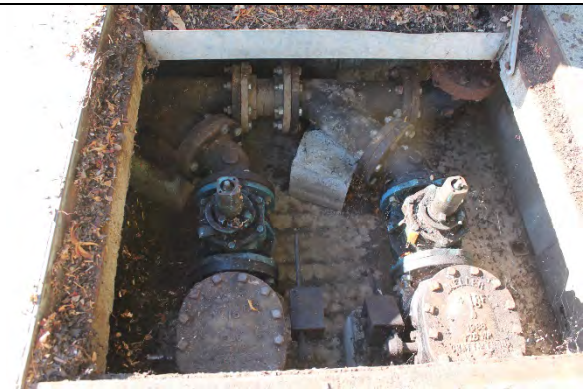
Valve vault concrete in fair condition. Isolation and check valves in fair to poor condition, respectively.

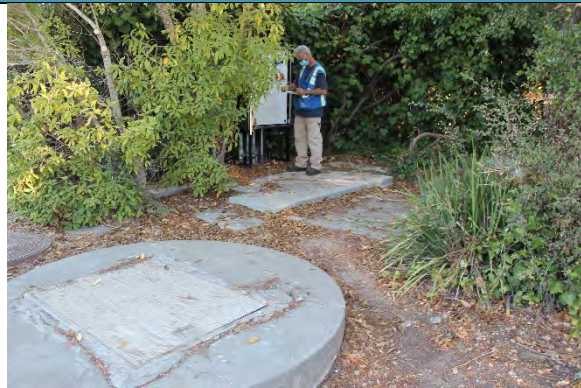
Wet well concrete top cracked and in poor condition.

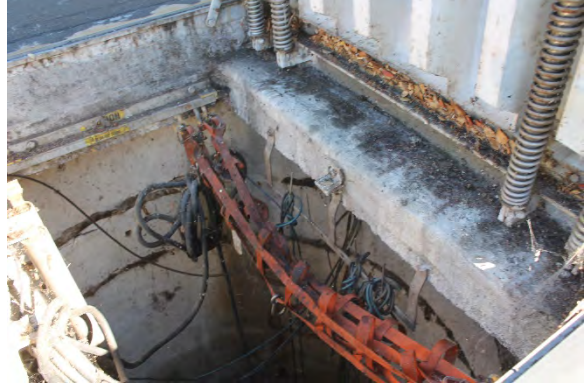
Wet well grout cracking and is in fair condition.

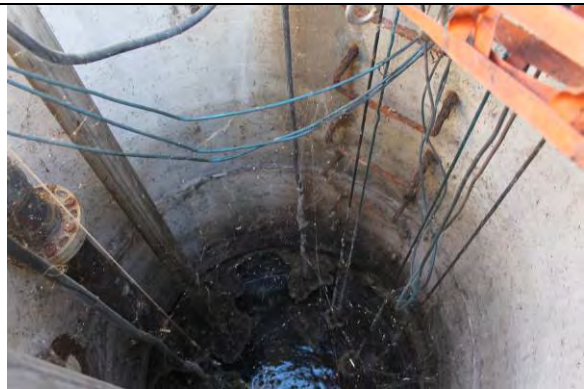
Wet well concrete is in fair condition. Access ladder is in very poor condition, extremely corroded, and should not be used.

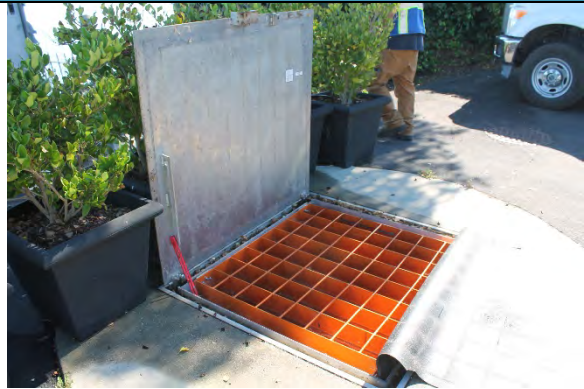
<p>Wet well access hatch and fall protection safety grate are in good condition. Odor issues reported.</p>
