**NOTICE AND AGENDA  
Regular Board Meeting  
Sanitary District No. 5 of Marin County  
Thursday, March 18, 2021**

# Collection System Master Plan

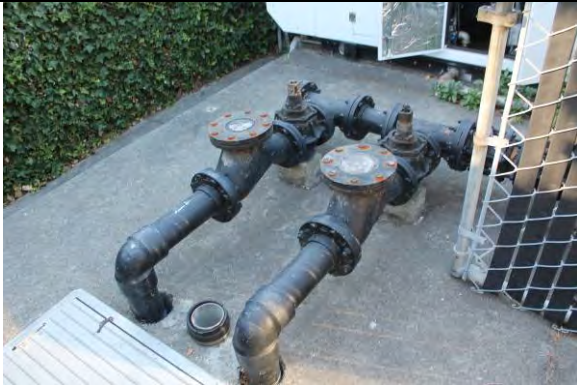
Check valves have not been upgraded.

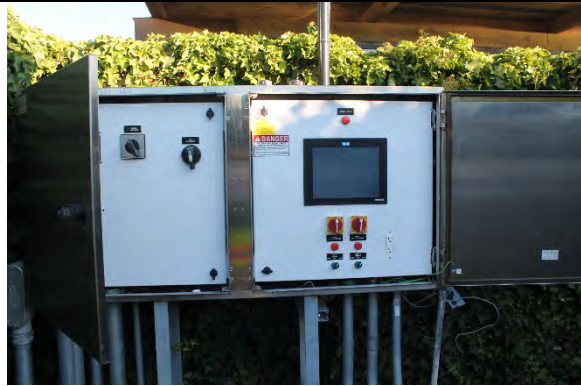
Electrical and I&C upgraded recently.

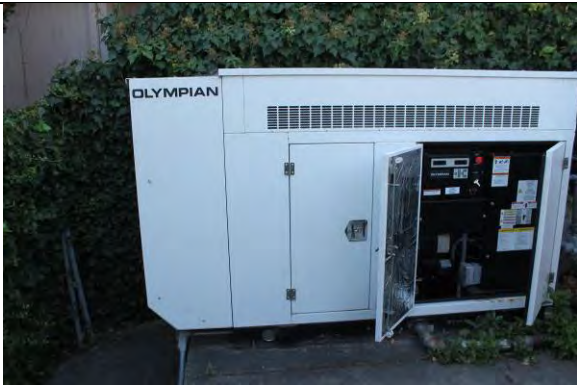
Generator upgraded recently and provides backup power to Tiburon 1 and 2.

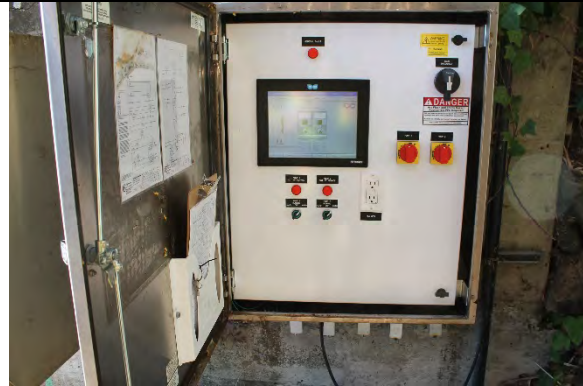
Electrical and I&C upgraded in 2015. Backup power provided by Tiburon 3 generator.

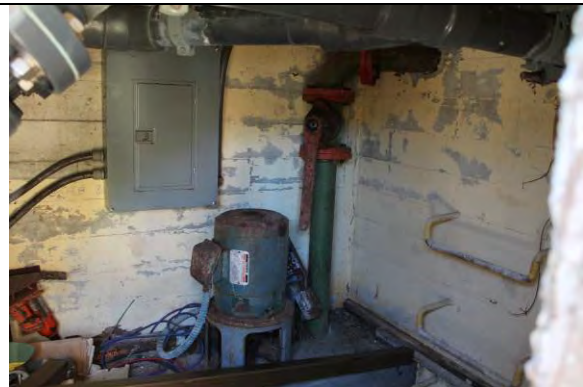
Old lift station.

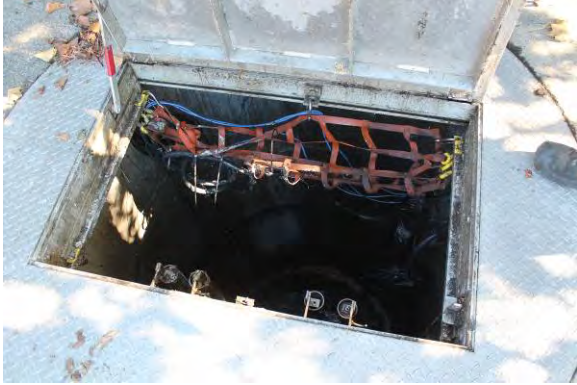
Wet well hatch in fair condition.

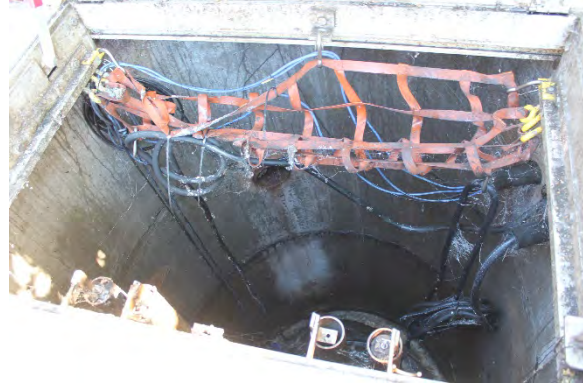
Wet well concrete in good condition.

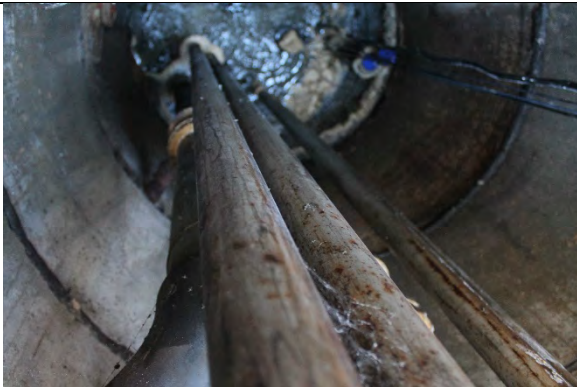
Wet well concrete and submersible pump rails in good condition. Heavy FOG exhibited during inspection.

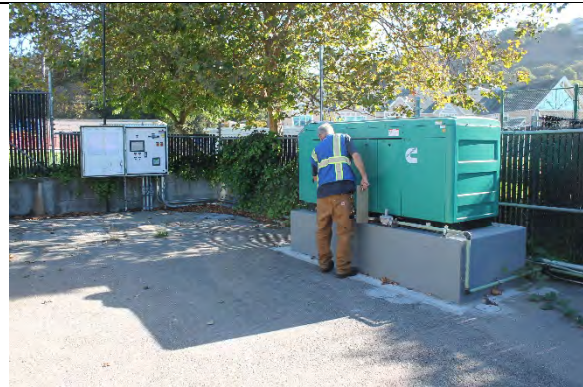
Recently upgraded natural gas backup generator.

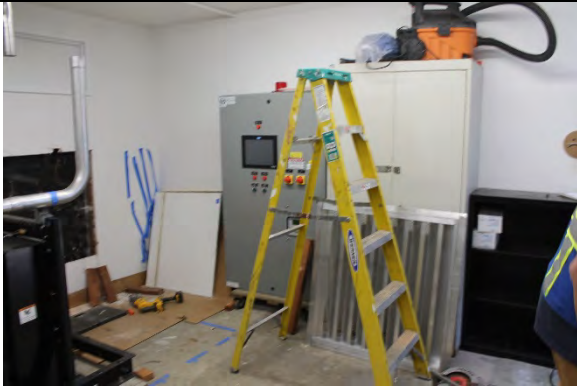
New electrical and I&C being installed during time of the inspection.

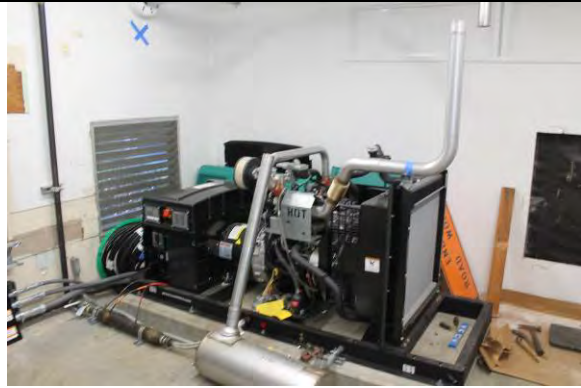
New backup generator being installed during time of the inspection.

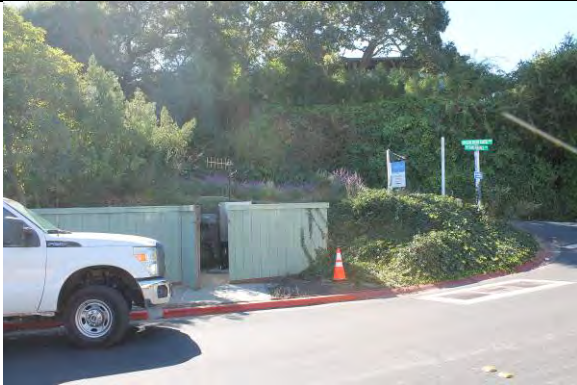
Lift station in good to poor condition. Odor issues reported. Previously had Bioxide odor control injection but was removed during the new backup generator installation. Instead currently using manhole odor control inserts for odor control. However, the Bioxide system is preferred.

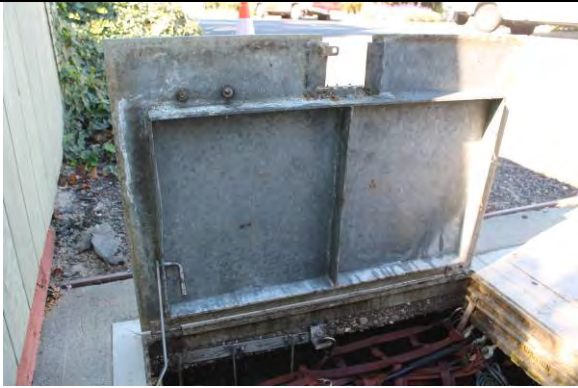
Wet well access hatches in fair condition exhibiting corrosion.

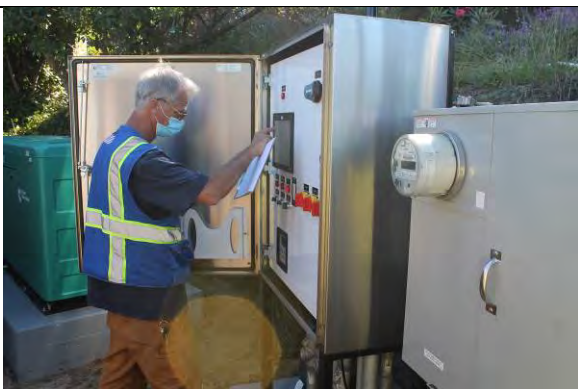
Electrical and I&C upgraded in 2017 and in very good condition.

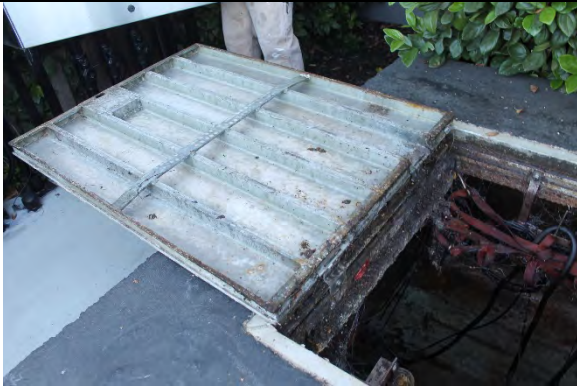
Wet well hatch in poor condition.

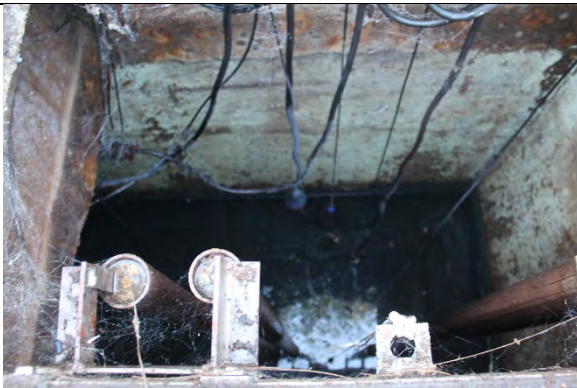
Wet well concrete in poor condition and exhibiting exposed aggregate and H<sub>2</sub>S corrosion. Previously painted.

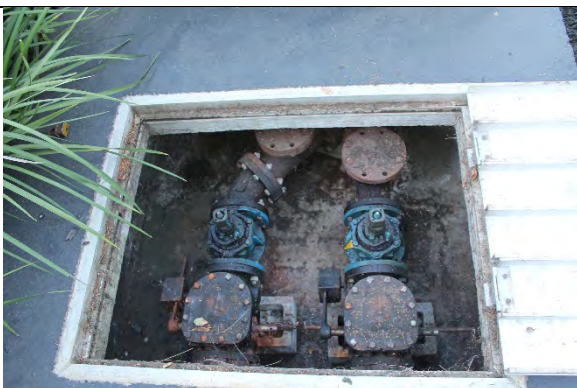
Isolation and check valves in fair and poor condition, respectively. Check valves were stuck.

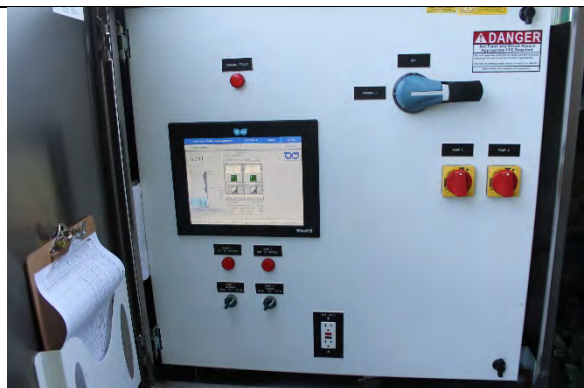
Electrical and I&C recently upgraded. Backup power provided by portable generator.

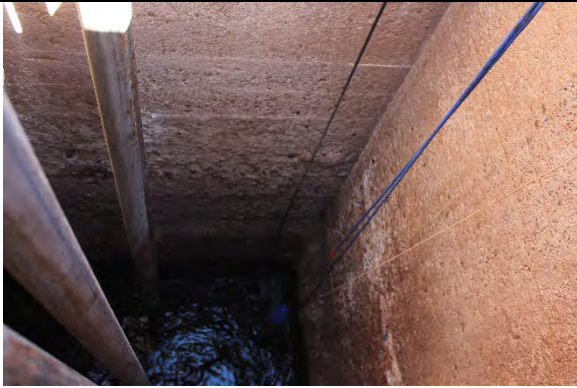
Wet well concrete in poor condition and exhibiting exposed aggregate, softness, and H<sub>2</sub>S corrosion.

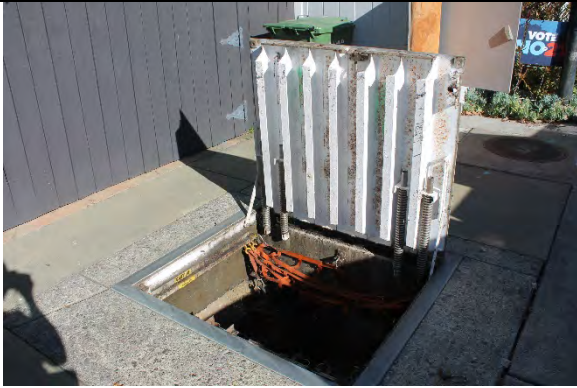
Painted wet well steel access hatch is in good condition and exhibiting light surface corrosion.

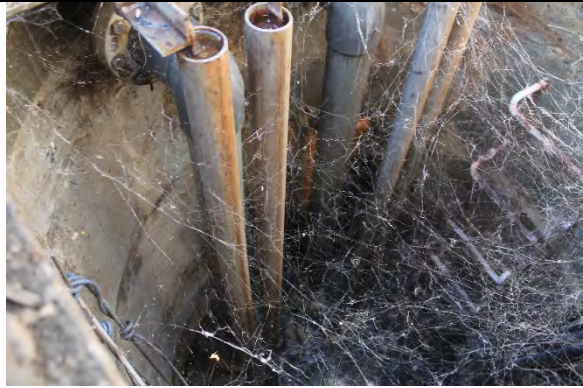
Wet well concrete in fair condition.

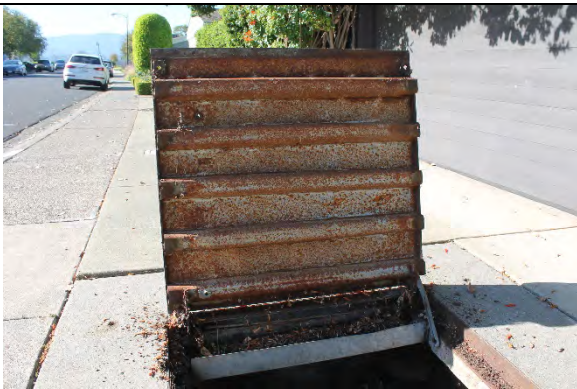
Valve vault steel access hatch is in fair condition and exhibiting moderate surface corrosion.

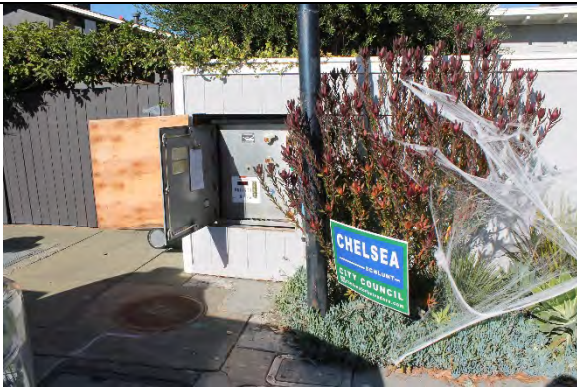
Lift station in fair condition. No access issues.

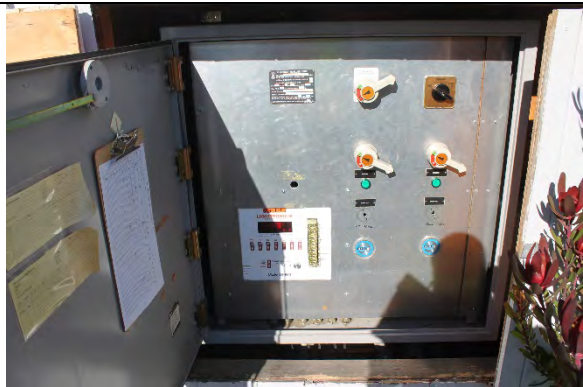
Older I&C scheduled to be upgraded.

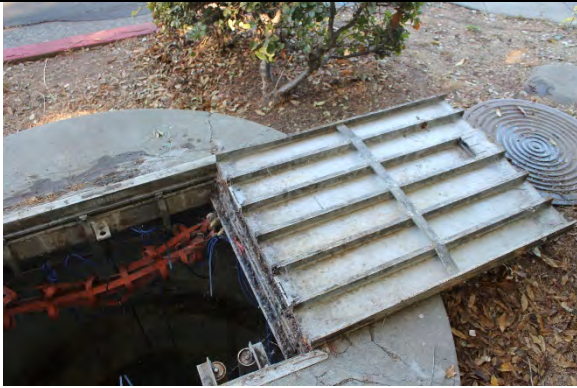
Wet well access hatch in fair condition and concrete top cracked and in poor condition.

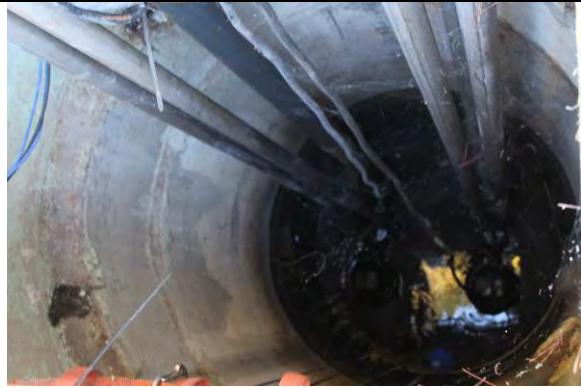
Wet well concrete in fair condition.

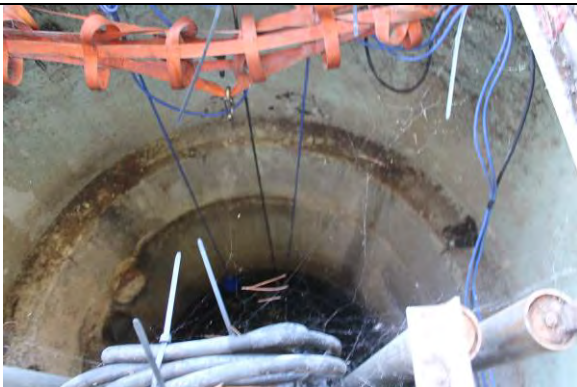
Wet well grout cracking and in fair condition.

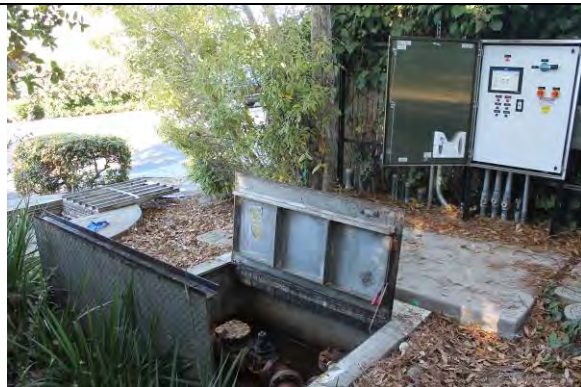
Valve vault concrete and access hatches in fair condition.

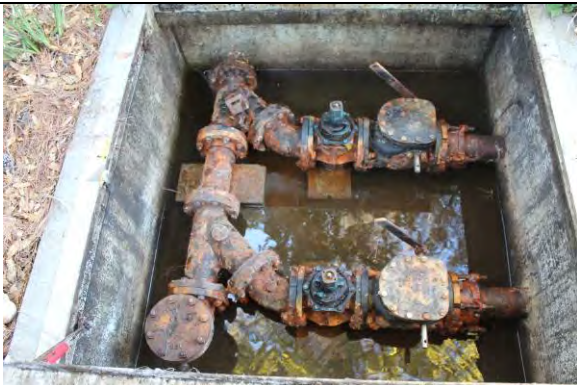
Standing water in valve vault causing piping surface corrosion. Isolation and check valves are in fair and poor condition, respectively.

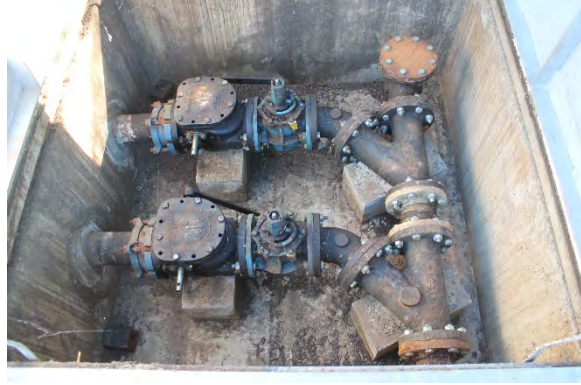
Isolation and check valves are in fair and poor condition, respectively.

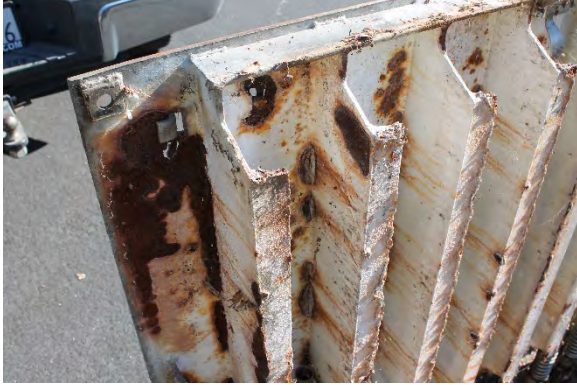
Painted wet well steel access hatch is in fair condition and exhibiting moderate surface corrosion.

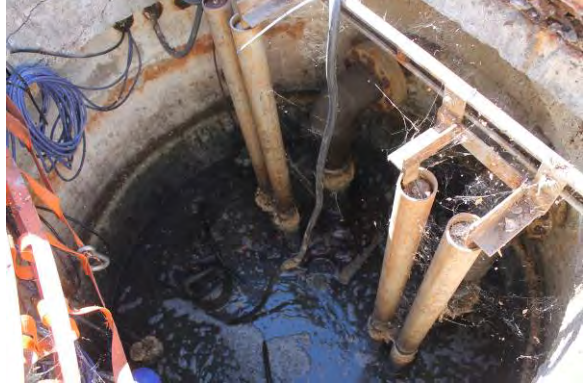
Wet well concrete in fair condition.

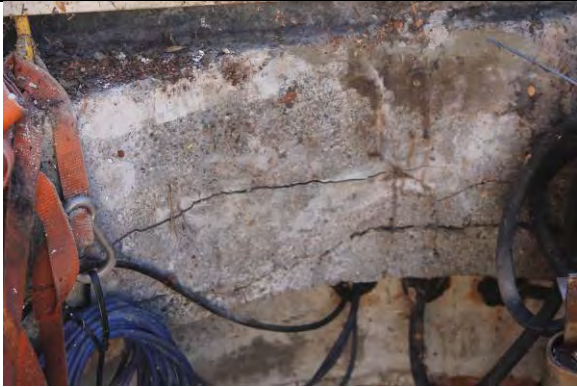
Wet well grout exhibiting cracking.

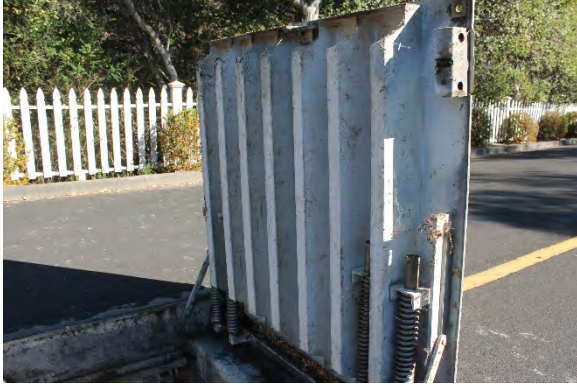
Painted wet well steel access hatch is in good condition and exhibiting light surface corrosion.

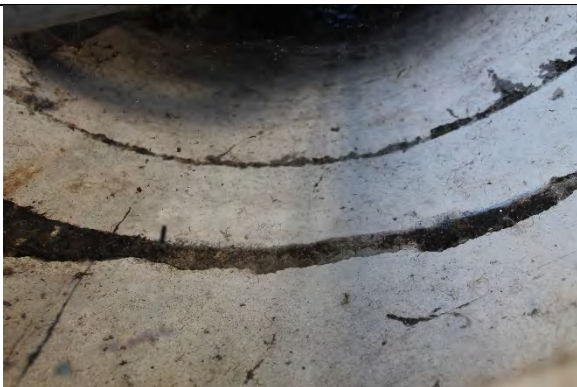
Wet well concrete is in fair condition.

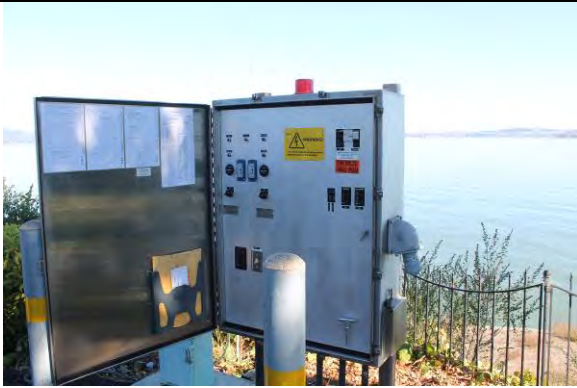
Seafirth 2 Lift Station

Electrical and I&C upgraded in 2009 and is in good condition.
