SANITARY DISTRICT NO. 5 OF MARIN COUNTY
2001 Paradise Drive
Tiburon, California 94920

Project: Cove Road Sewer Rehab

Draft Collection System Master Plan

Sanitation District No.5 of Marin County

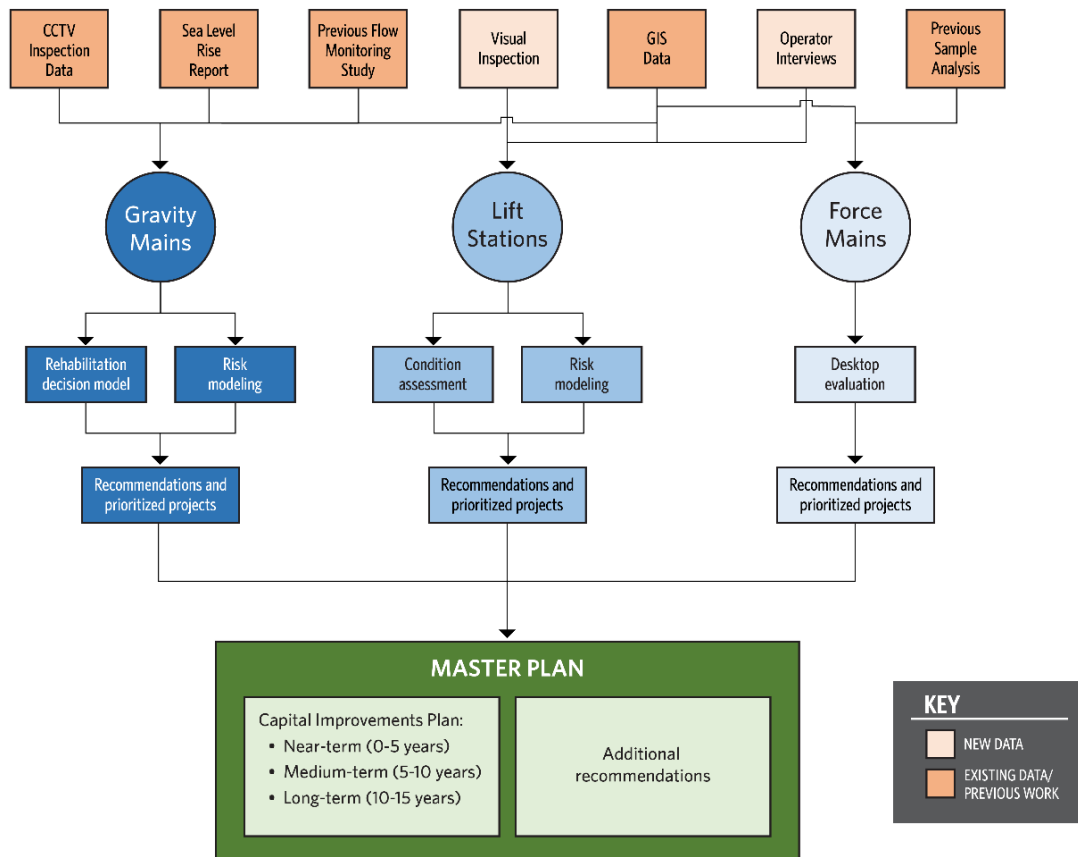
Figure 1. Master plan project approach

Figure 1 provides the approach to developing the Master Plan. The three primary components of the collection system - gravity mains, lift stations, and force mains - were each evaluated using existing information from SD5 and new data developed for this study. Evaluation of the gravity mains consisted of developing a risk model from the available CCTV inspection data and a rehabilitation decision model that also incorporated findings from the evaluation of the 2010-2011 flow monitoring study (E2 Consulting Engineers Inc., 2011) and sea level rise assessment (BVB Consulting LLC, 2017). The lift station evaluation incorporated existing data from SD5 as well as new data from physical inspections and interviews of operations staff. The force mains were evaluated using available data from the GIS and sample analysis results of four pipe samples from 2018 Visual Condition Assessment Report (V&A Consulting Engineers, 2018). Each of these three primary components was evaluated separately to identify prioritized recommendations, which were then integrated into a comprehensive 15-year capital improvement plan (CIP).

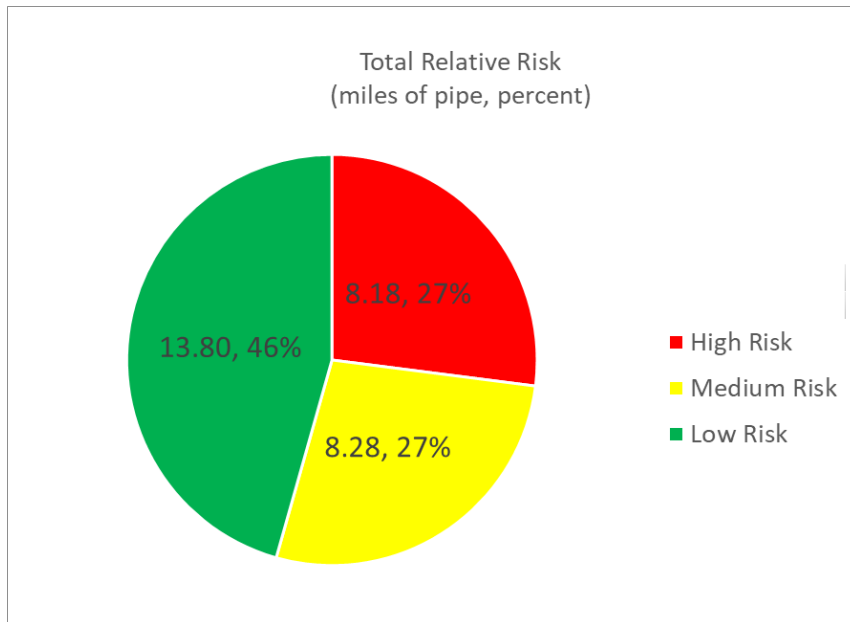
Figure 2. Risk modeling results for gravity mains

The LoF and CoF scores are comprised of several components based on physical characteristics of the system, CCTV inspection results, regulatory history and customer service. These were tabulated for every gravity main to develop the final risk score. The risk model for the system, summarized in Figure 2. Risk modeling results for gravity mains, shows that about 27 percent (8.18 miles) of the gravity mains have a relatively high risk compared to the rest of the system. However, these pipes do not all require rehabilitation.

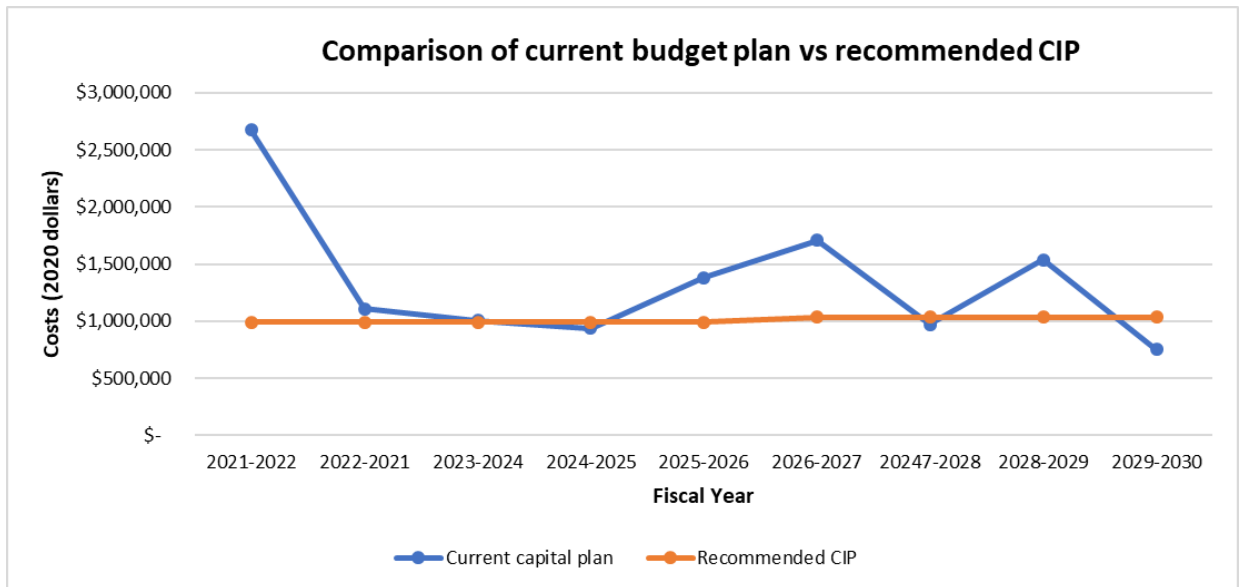
Figure 4. Comparison of the recommended CIP and the SD5 fiscal plan

Figure 4 compares the existing SD5 capital plan as provided in the FY 2020-2021 Final Budget report (SD5, 2020b) to the recommendations from this master plan. The planned budget averages approximately \$1.2 million whereas the recommended projects from this Master Plan average approximately \$1.0 million over the same time period.

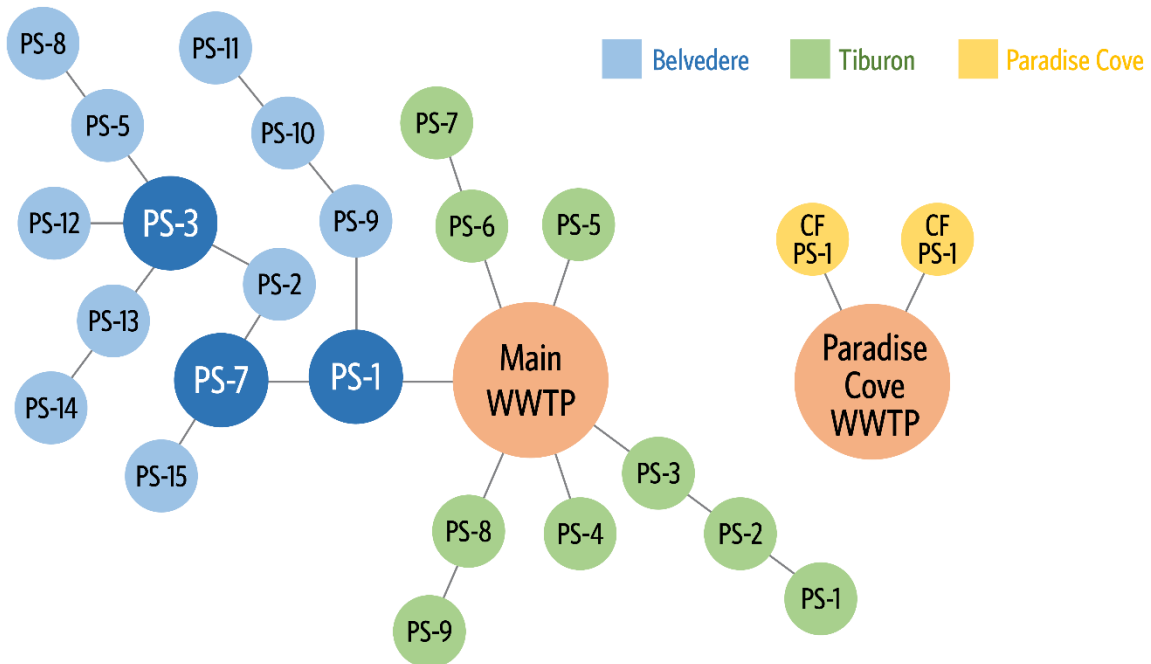
Figure 6. SD5 collection system schematic

SD5 collection system infrastructure is divided into two systems as shown in Figure 6: (1) the Main Treatment Plant collection system, which services all of the City of Belvedere and the southeastern and central portion of the Tiburon peninsula and (2) the Paradise Cove collection system, which services the northern portion of the Tiburon peninsula along the coast. In these two systems, SD5 manages about 30 miles of gravity pipelines, which include 772 manholes, 98 rodholes, and 19 cleanouts (Figure 7). Where gravity flow is not viable, SD5 pumps wastewater to its treatment plants through 24 lift stations and about 4.5 miles of force mains. Each of these systems is described in more detail in the following paragraphs. Information provided is based on SD5s geographic information system (GIS) database (SD5, 2020a).

A schematic of the lift stations and how they pump water to the treatment plants is shown on Figure 6. Tiburon lift stations PS-3, PS-5, PS-6, and PS-8 are main collection points in the Tiburon service areas, receiving wastewater from other lift stations and a large part of the collection system, constituting about 41 percent of SD5's system by sewer pipe miles (Table 10). In the Belvedere service area, all flows are received at PS-1, which conveys flows from about 37 percent of SD5's system by sewer pipe miles. Other important Belvedere lift stations include PS-2, PS-3, and PS-7 which collect wastewater from 17 percent, 12 percent, and 24 percent of SD5's system by miles respectively.

For this part of the assessment, each station was ranked based on impact to the service area if the station was taken out of service. In general, lift stations that receive wastewater conveyed from other lift stations upstream in the collection system will have a greater impact if they are unable to pump water. Table 37 shows the assessment of impact based on the number of lift stations linked to each station. The lift stations are sorted in descending order within each of the three service areas. These relationships can be seen in detail in the lift station schematic diagram in Figure 6, above, and in Table 37, below.

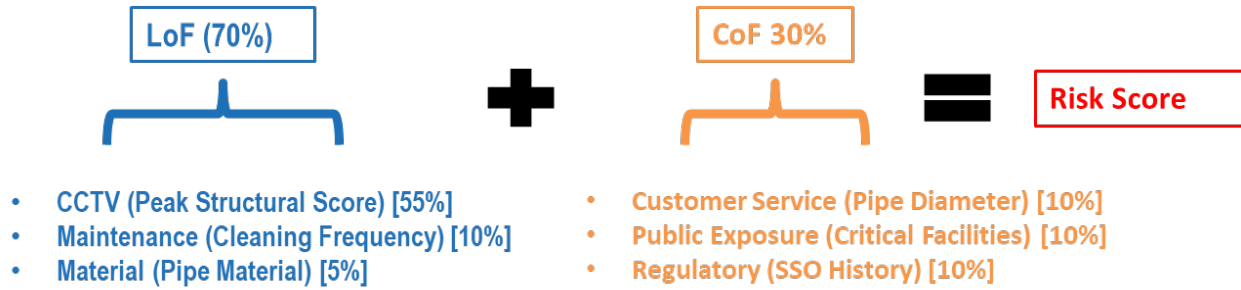
Figure 10. Gravity main risk formula

The risk score is calculated as the weighted summation of the LoF and CoF values. The formula used is shown in Figure 10. For each pipe, numerical values assigned for each of the CoF and LoF categories are multiplied by the weighting factor shown in parentheses. The LoF scores are summed together, the CoF scores are summed together, and the total values for each are added together to obtain the final risk score. The LoF represents the majority of the risk score (70 percent) to identify pipes that can be rehabilitated to drive down the risk. In other words, if more emphasis is placed on CoF values, pipes that are in good condition that have a high CoF (e.g., large pipes next to schools or hospitals with no structural problems) may consistently show higher risk scores than pipes that are more likely to fail (e.g., smaller-diameter pipes with structural problems that could cause a sewer system overflow [SSO]).

The focus of this analysis is assessment and mitigation of risk in order to prevent SSOs. Risk was calculated using the formula shown in Figure 10, above, which yielded a relative risk score for each gravity sewer main. The risk scores are relative to SD5's collection system as a whole, meaning that they are used to determine priorities within the system, not to quantify potential failure. The risk results are shown on the pie chart in Figure 7 which shows the percentage in each category by linear footage. For the gravity pipes in SD5, the risk scores ranged from 5 to 78 out of a total possible score of 100. A risk score of 100 represents the highest possible risk (e.g., the maximum scores for each category assigned to a given pipe). A risk score of 0 represents the lowest possible risk. The risk scores represent a score relative to the calculated risk for other pipes in the system and not an absolute risk score and is a general indication of which pipes should be rehabilitated or replaced first according to the criteria.

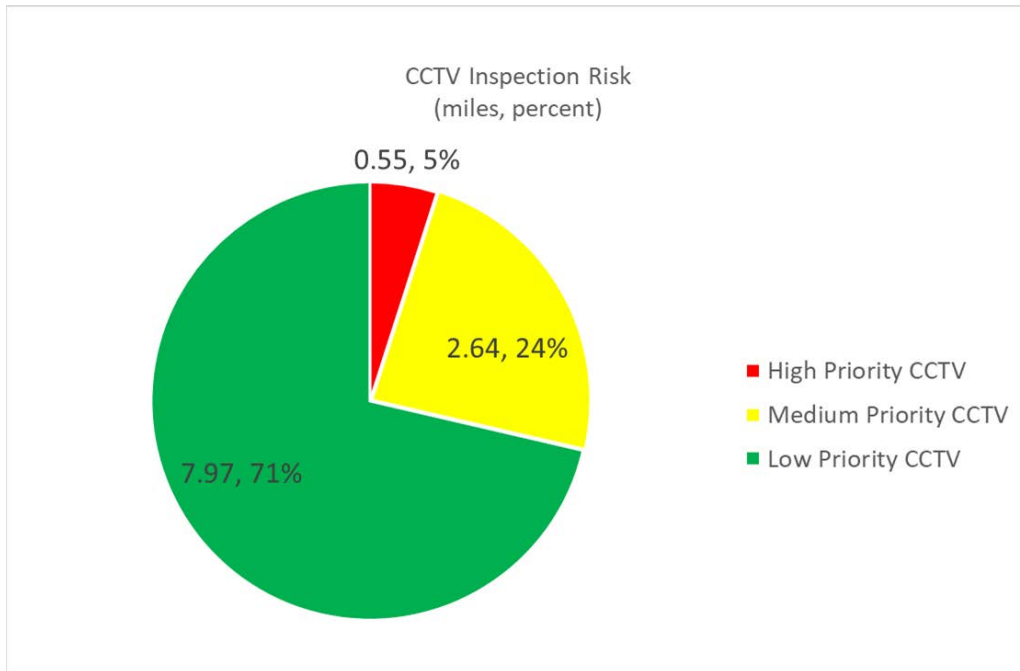
Figure 15. CCTV model results – no risk threshold

Figure 15 provides a similar summary for all future pipe inspections identified in the model. These inspections are categorized as high, medium, and low priority based on pipe risk scores and the established cutoff values. The cost and total sewer main length is provided for each category, as well as category percentages (shown in the pie chart). Gravity mains are identified for future inspections if they meet one of the following criteria:

- No historical CCTV data
- No structural PACP defects on the most recent CCTV
- Does not meet the required criteria to receive a rehabilitation recommendation

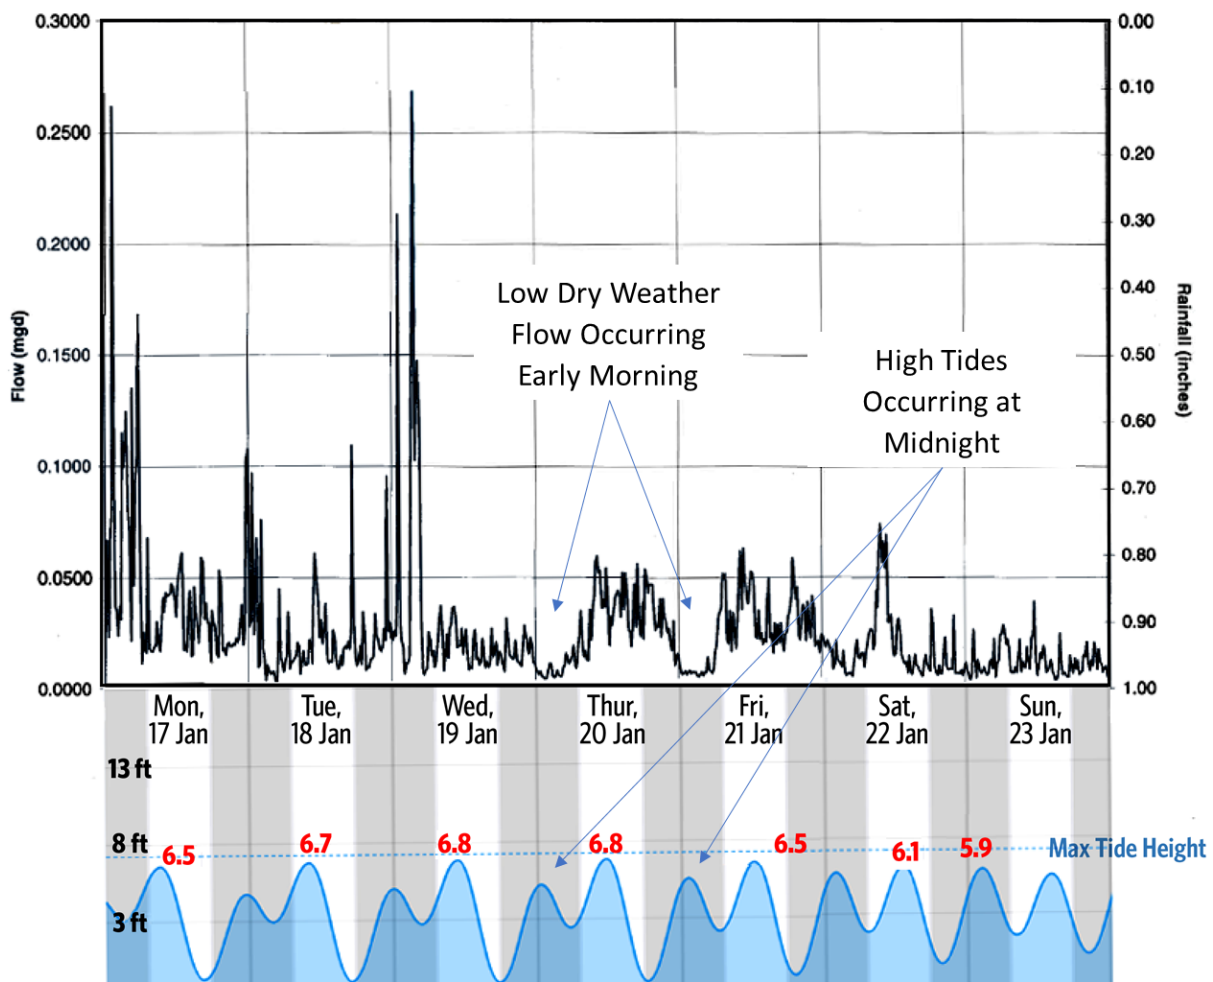
Figure 19. Measured flow correlated to hourly tides

In basins monitored near the bay, the flow data generally do not show an increase that corresponds to the time of high tide during non-rain days. Figure 19 below presents an example of flow data from Basin 10 compared to tide level changes on an hourly basis (E2 Consulting Engineers Inc, 2011). The example period is chosen as there were no wet weather events to influence the data. As shown, measured flows are at the minimum level around midnight and gradually increase after around 6 a.m. Measured flows fluctuate through the daytime and gradually decrease after around 11 p.m. Such a flow pattern is typical for most monitored basins and is an indication that the hourly flow is driven mainly by diurnal sanitary flow when dry weather conditions are present. High tides in the bay occur approximately every 12 hours and 25 minutes and are shown on the graph in the bottom of the figure. The daily changes in flow do not appear to correlate with the tidal fluctuations shown for the same period. The lowest flow periods are consistently in the early morning hours of each day whereas the lowest tides are occurring around sunrise and sunset. There may be a daily contribution from tidal changes; however, it is not significant enough to be reflected in the flow monitoring hydrographs. Similar results were also observed in other basins reviewed.

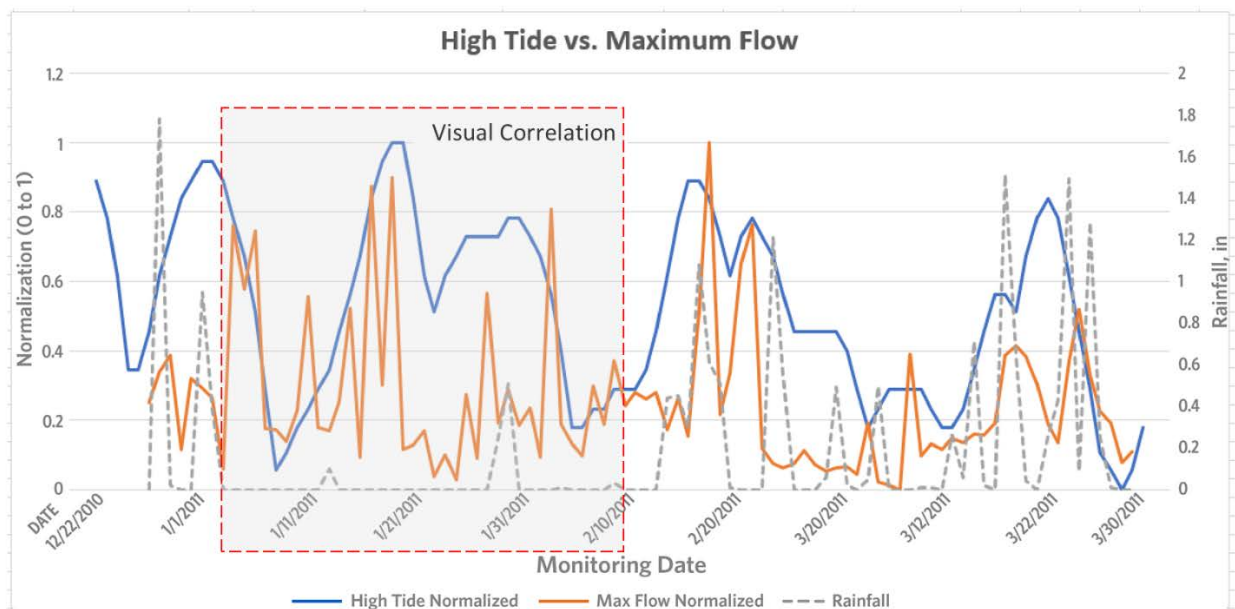
Observations in Basin 10, as shown in Figure 20, indicate a consistency between normalized high flow data and normalized high tide data from early January to mid-February 2011. This suggests that Basin 10 flow may be influenced by high tides that exceed a certain height which cause infiltration or inflow. Smaller high tides may not be sufficient to enter the system. **This is not likely to be a major impact on I&I overall; however, it could become worse as sea level rises.**

Figure 20. Peak flow data correlated to maximum tides in Basin 10

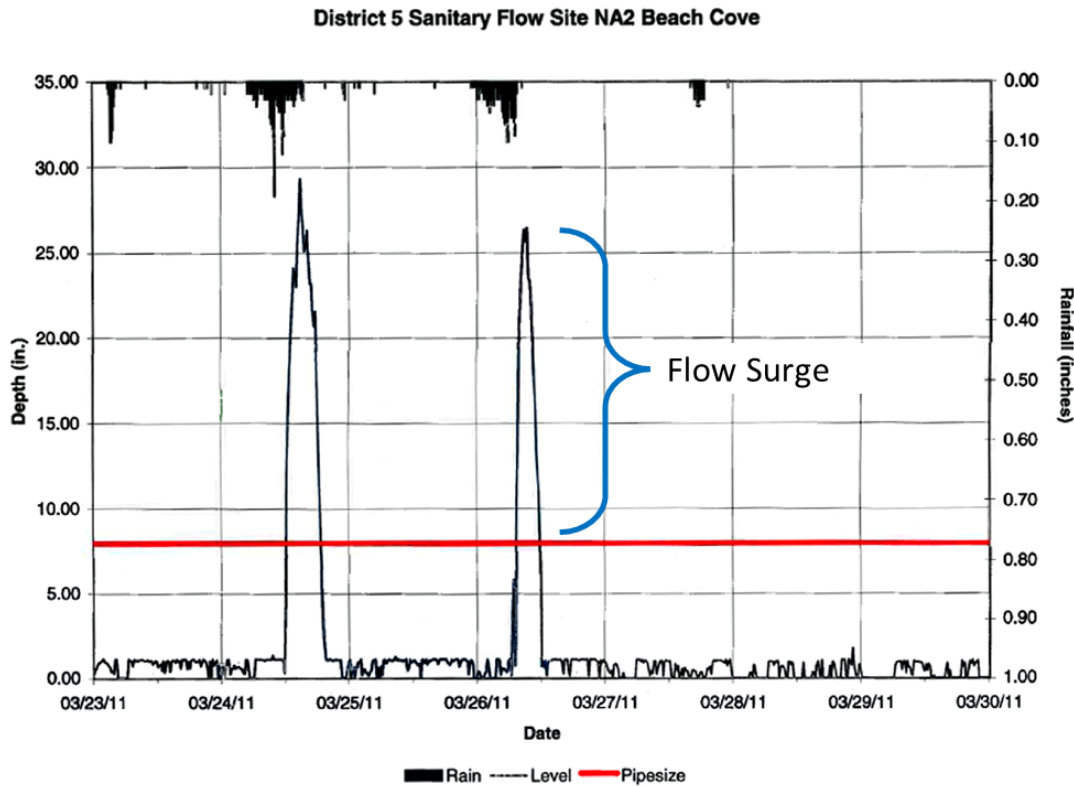
The hydrographs were also reviewed to determine if the height of any of the wet weather flow surges exceeded the pipe diameter. ***This may indicate a potential capacity issue at the monitoring site. This condition was observed in Basins 6 and 7.*** Two examples are shown in Figure 25, which captures two storm events that occurred on March 24 and 26, 2011 in Basin 7 (E2 Consulting Engineers Inc, 2011). The count of these instances observed by basin is recorded in Table 30 below. The peaks of these flow surges are sharp, which suggests that they did not overflow the manhole. SD5 can estimate the surge elevation in the manhole if the total depth from the top of the manhole to the bottom of the pipe is known; however, this information was not available for this analysis. It is also not possible to determine the behavior of the flow in upstream or downstream manholes that were unmonitored, which could be experiencing worse surcharging. ***It is recommended that SD5 monitor Basins 6 and 7 manholes during peak storm events to determine capacity risks and consider installing remote sewer monitoring (e.g., SmartCovers) if necessary.***

Figure 25. Example of flow surges larger than pipe diameter in Basin 7

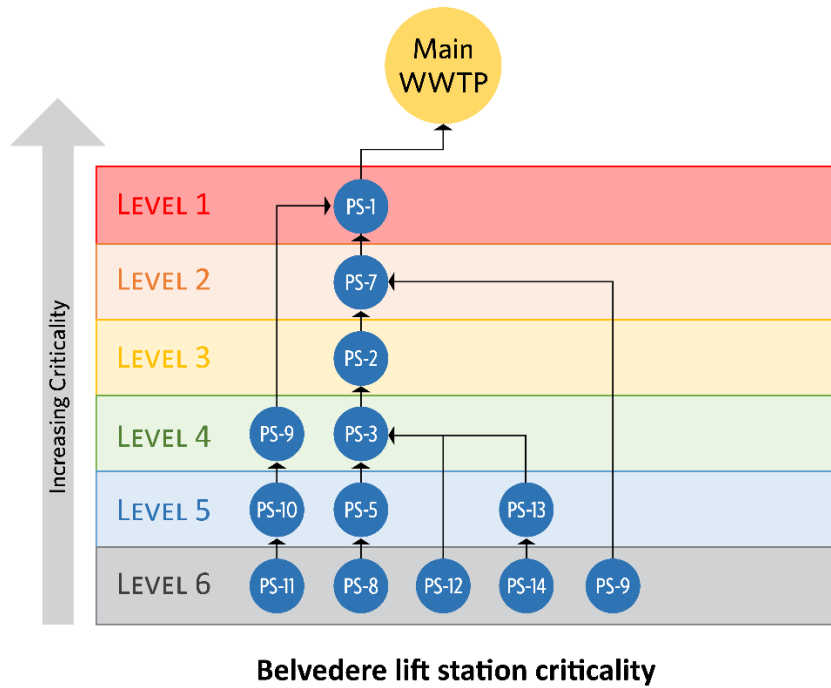
Figure 30 shows the lift station priority levels for the Belvedere service area. Lift Station PS-1 is the highest-ranking lift station as the entire service area flows into it. Lift Station PS-7 is assigned to the second-level priority because it receives wastewater from eight other stations and collects water from about 78 percent of the Belvedere system. Next in priority is Lift Station PS-2, which captures 55 percent of the system, then Lift Stations PS-9 and PS-3 are assigned to level 4, because they both convey water from multiple stations. Lift Stations PS-5, PS-10, and PS-13 also receive flow from upstream stations, and finally, Lift Stations PS-8, PS-11, PS-12, PS-14, and PS-15 are assigned the lowest priority: level 6.

Figure 28. Belvedere lift station criticality
 (Arrows illustrate flow path to the WWTP)

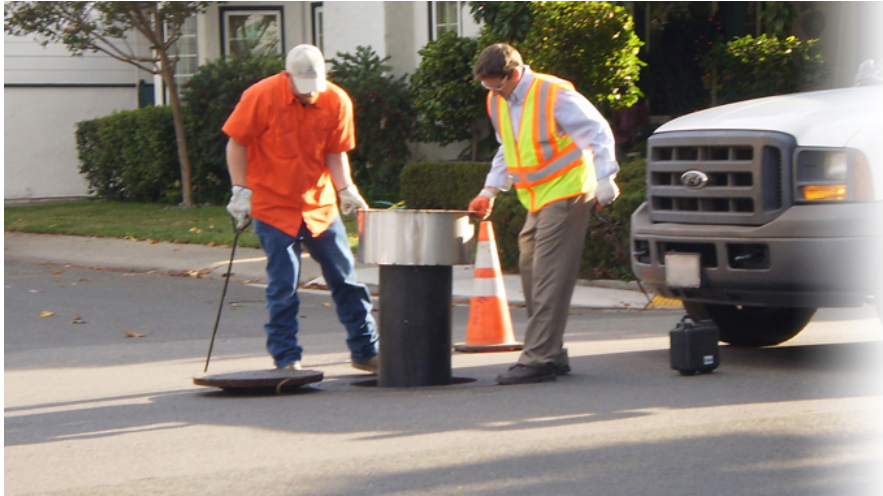
Figure 30. The Mole™ manhole insert with 20 lb. activated carbon to eliminate odors or equivalent device

3. Install passive manhole inserts with activated carbon units, as shown in Figure 30.
4. Install passive external activated carbon units, as shown in Figure 31.
