**NOTICE AND AGENDA  
Regular Board Meeting  
Sanitary District No. 5 of Marin County  
Thursday, March 18, 2021**

# Collection System Master Plan

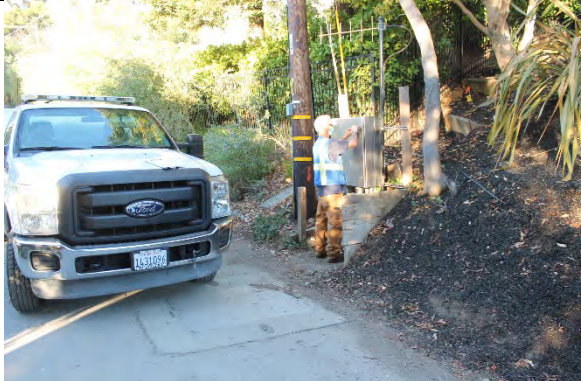
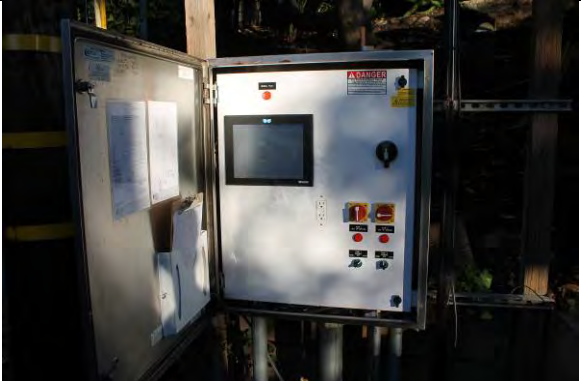
Tiburon 1 Lift Station

<p>Lift station in good condition. Serves only several residential homes. No access issues.</p>	<p>Electrical and I&amp;C upgraded in 2014. Backup power provided by Tiburon 2.</p>

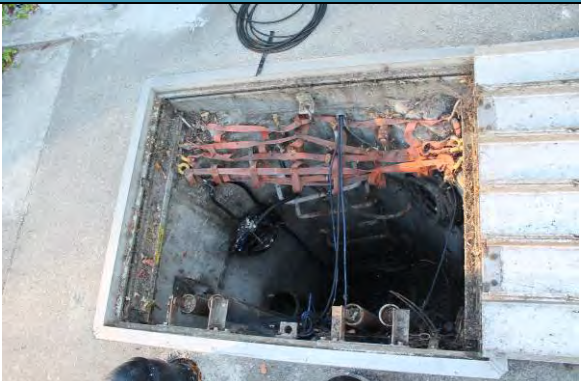
Tiburon 2 Lift Station

<p>Lift station in fair condition. No access issues.</p>	<p>Wet well concrete and hatch in fair condition.</p>

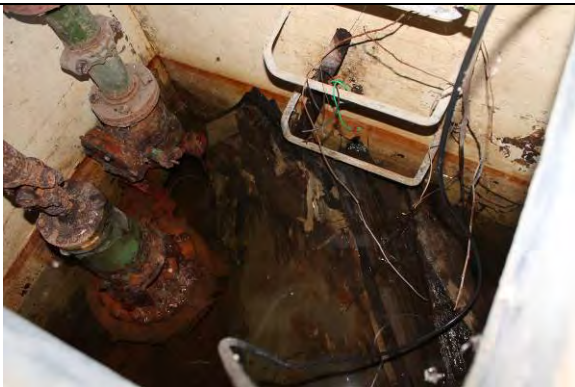
Old lift station wet well.

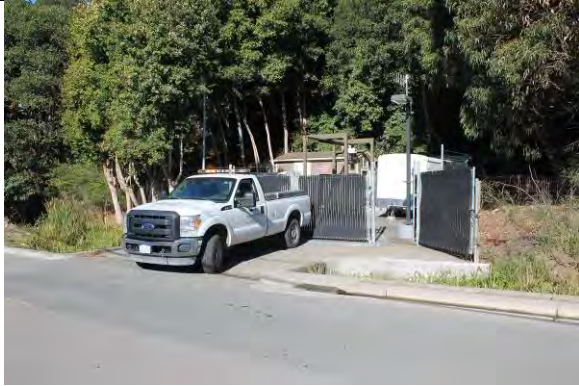
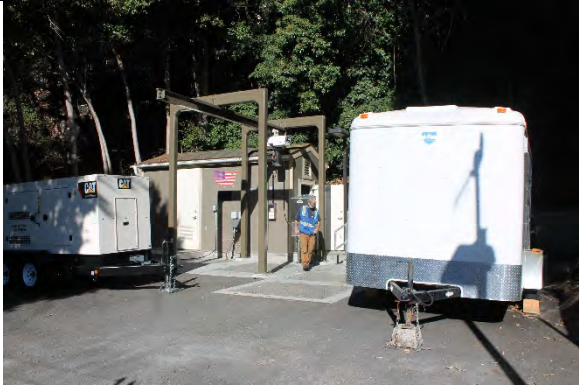
Tiburon 5 Lift Station

<p>Lift station in very good condition. No access issues. Completely upgraded in 2019.</p>	<p>Lift station in very good condition. No access issues.</p>

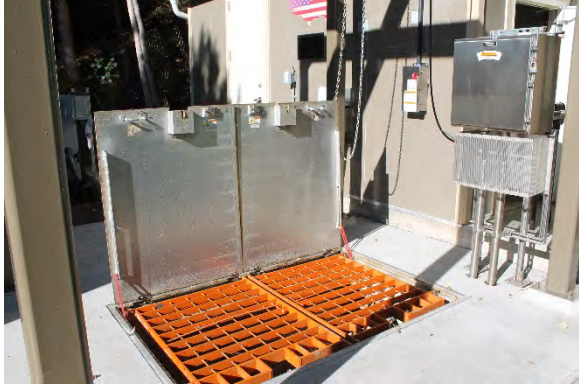
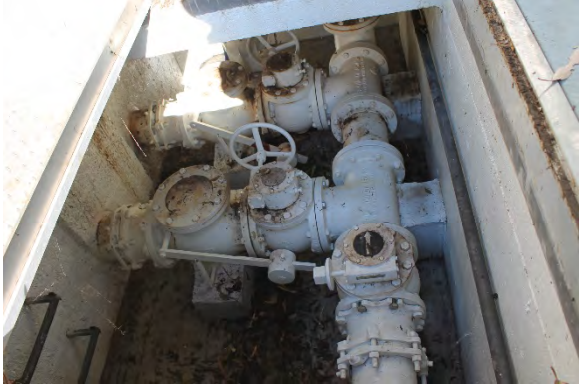
<p>Access hatches and fall protection safety grates in very good condition. Submersible pumps in wet well.</p>	<p>Effluent check and isolation valves and manifold in very good condition.</p>

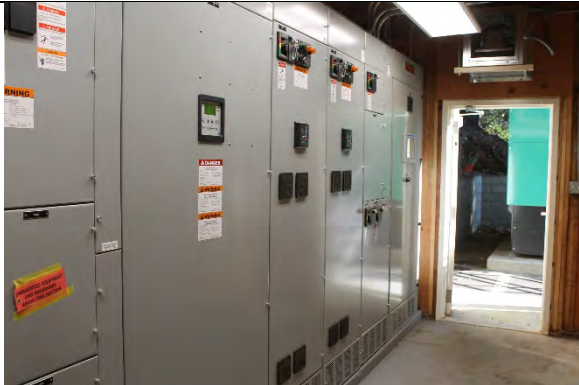
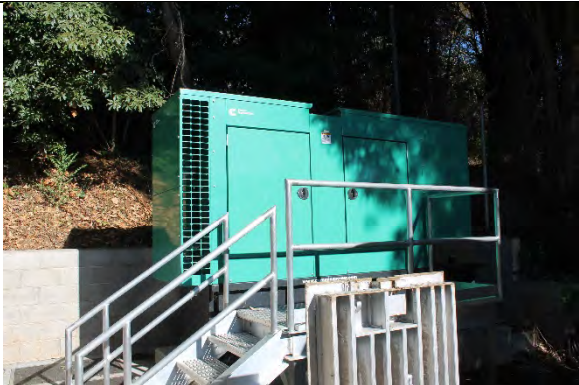
<p>MCC located in electrical building and in very good condition.</p>	<p>Generator in very good condition.</p>

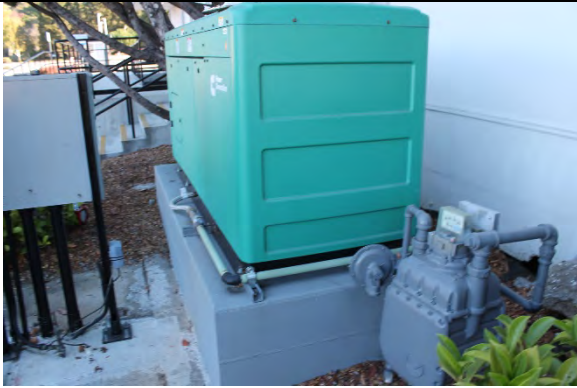
Natural gas backup generator upgraded in 2018 and is in very good condition.

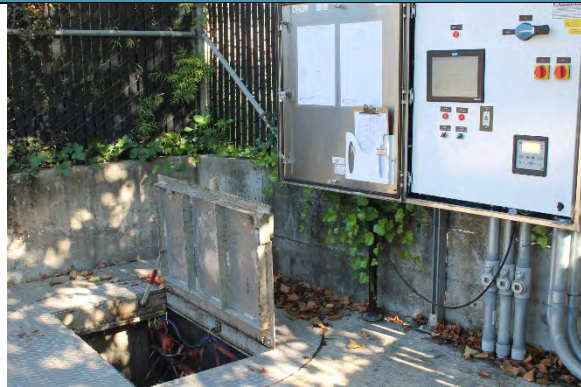
Electrical and I&C upgraded in 2017 and in very good condition.

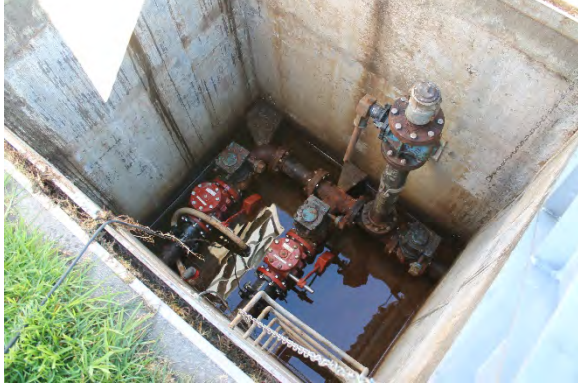
Valve vault concrete and hatch in fair condition. Standing water was pumped out with manually operated sump pump. The check valves were recently replaced because of failure.

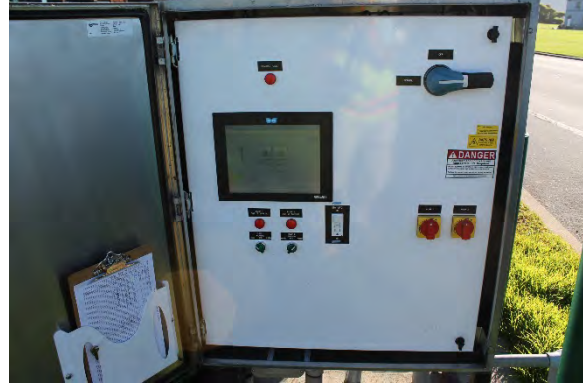
Electrical and I&C upgraded in 2015. Backup power provided by portable generator.

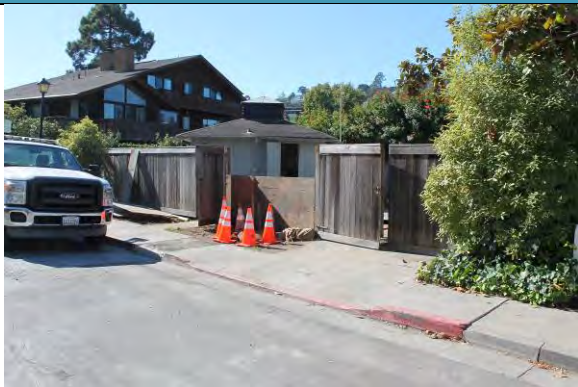
Lift station in fair to poor condition. All Belvedere lift stations pump to Belvedere 1. No access issues.

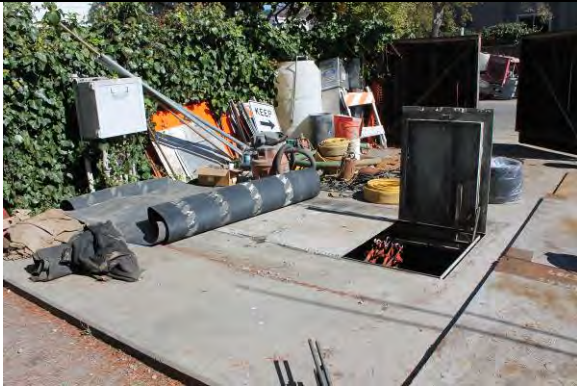
Wet well access hatches in fair condition. New parallel force main was being installed during inspection. High groundwater exhibited in the new parallel force main trench. There are no current plans to upgrade the lift station.

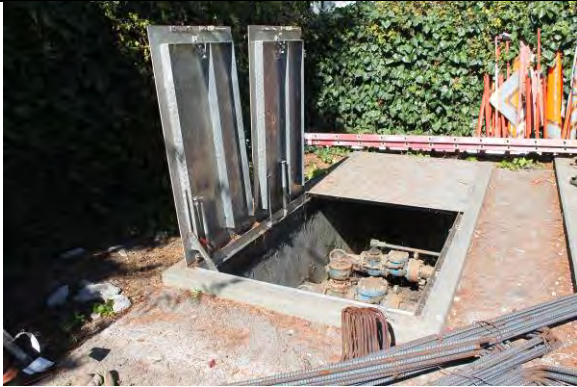
Valve vault concrete and hatches in fair condition.

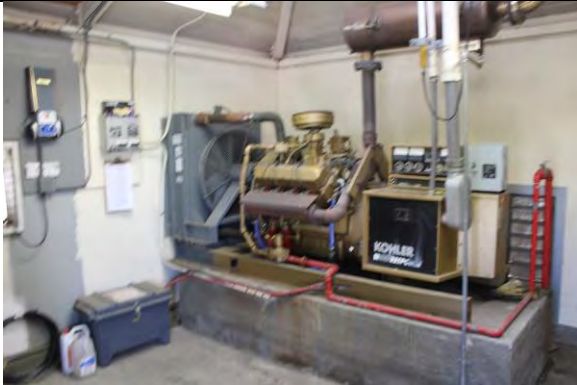
Older backup generator beyond its useful life.

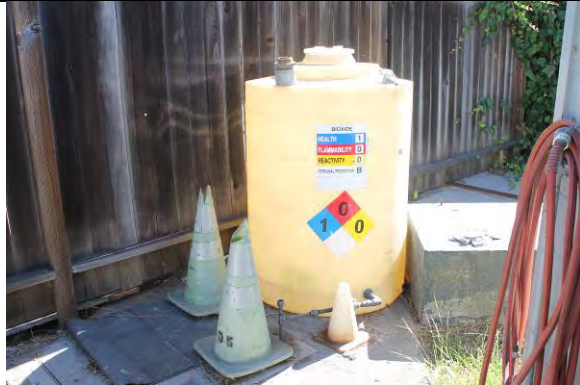
Odor issues reported. Odor control injection system currently disconnected.

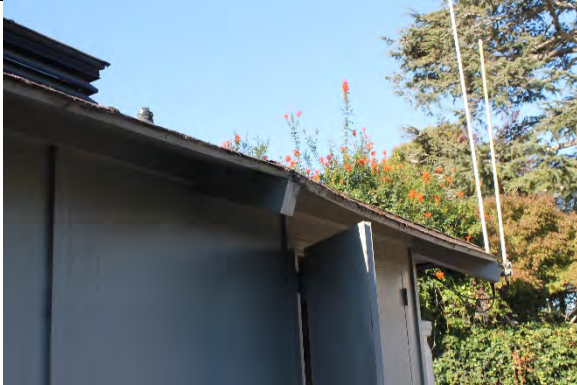
Lift station building roof in poor to very poor condition.

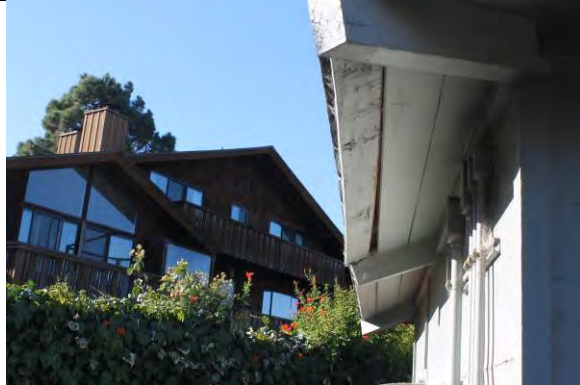
Lift station building roof in poor to very poor condition.

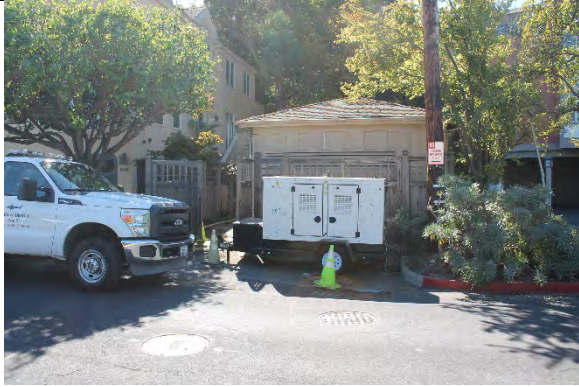
Lift station in fair condition. No access issues.	Access hatches to wet well and in fair condition.

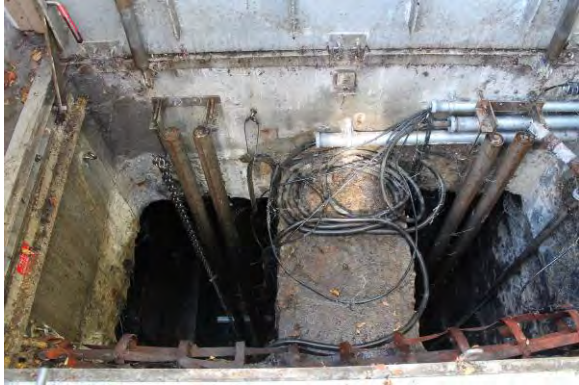
Wet well in fair condition and appeared to be coated with coal tar.	Wet well at access hatch experiencing exposed aggregate and H <sub>2</sub> S corrosion.

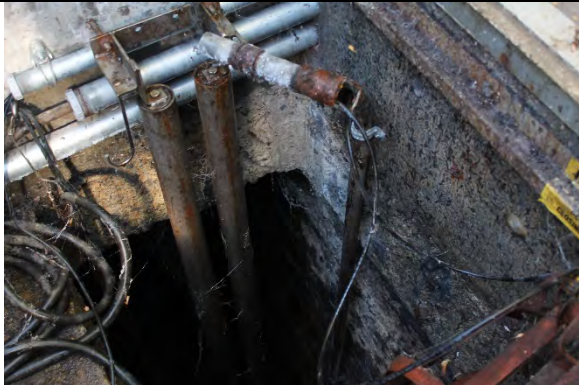
Wet well at access hatch experiencing exposed aggregate and H <sub>2</sub> S corrosion.	Electrical, I&C, and automatic transfer switch are being upgraded during the time of the inspection.

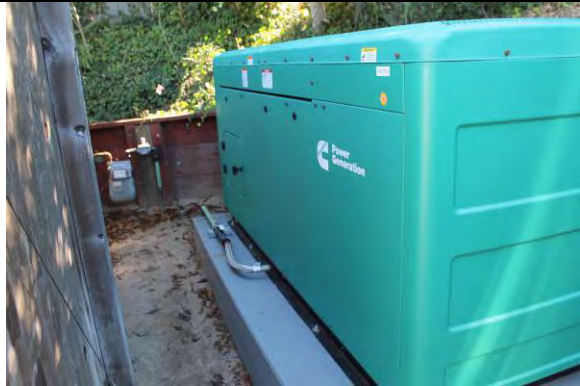
Natural gas backup generator upgraded in 2017 and in very good condition.

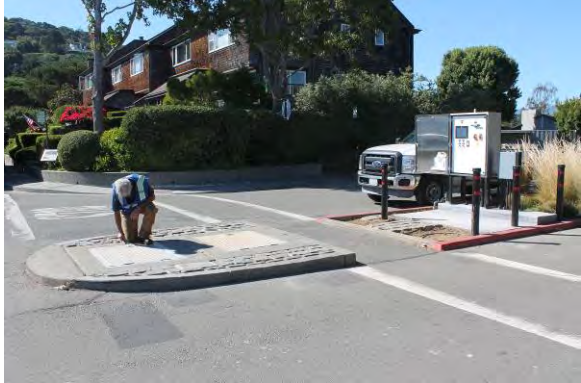
<p>Lift station in poor condition. Odor and pipeline settling issues reported. Electrical and I&amp;C recently upgraded.</p>

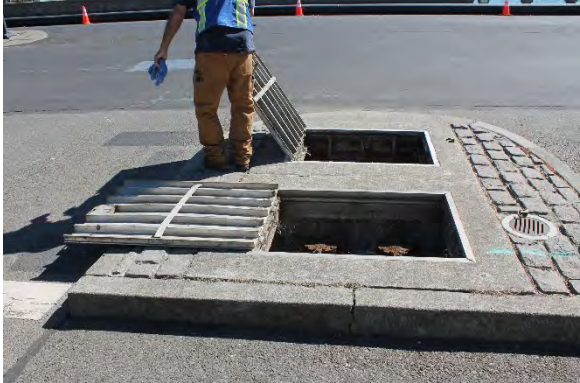
<p>Wet well access hatch in very poor condition.</p>

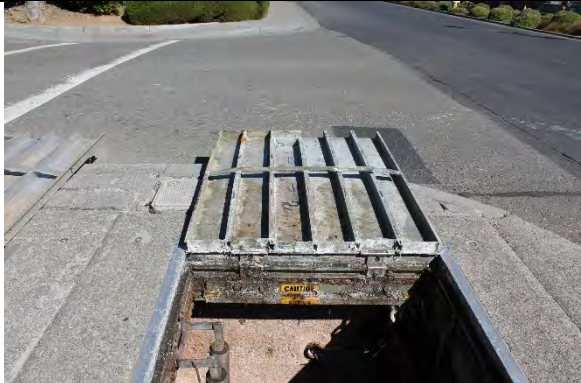
<p>Wet well access hatch in very poor condition. Excessive corrosion might be caused by brackish water.</p>

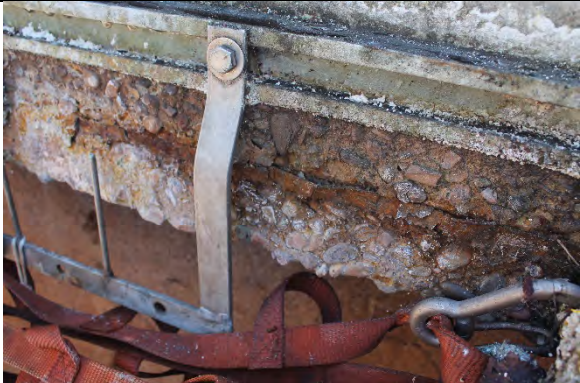
<p>Wet well concrete in poor condition and exhibiting exposed aggregate and H<sub>2</sub>S corrosion.</p>

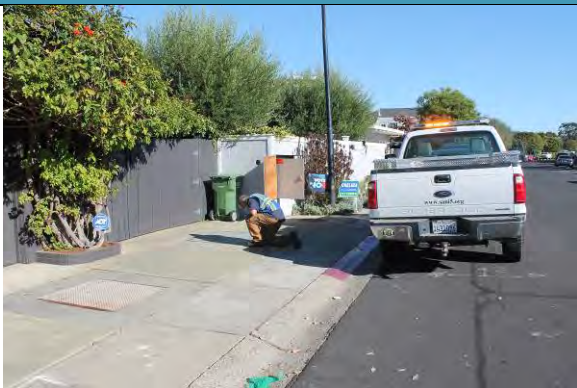
Lift station in fair condition. No access issues.

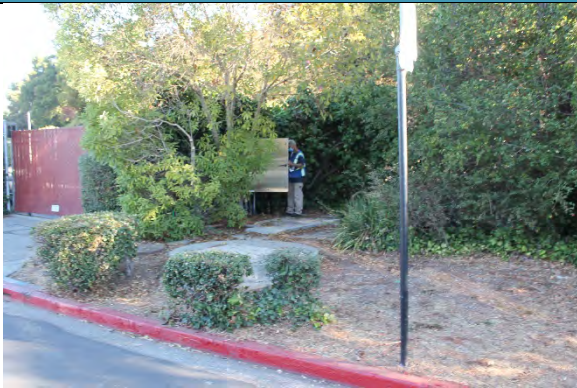
Lift station in fair condition. No access issues.

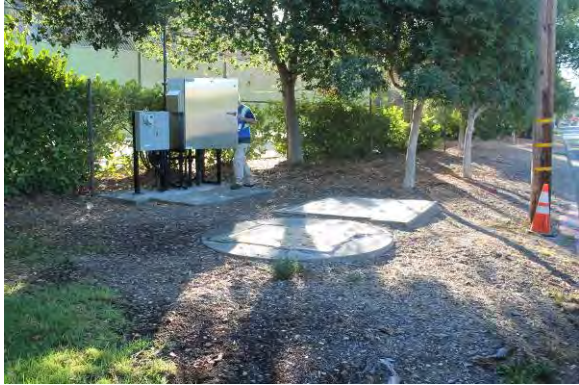
<p>Lift station in fair condition. No access issues.</p>

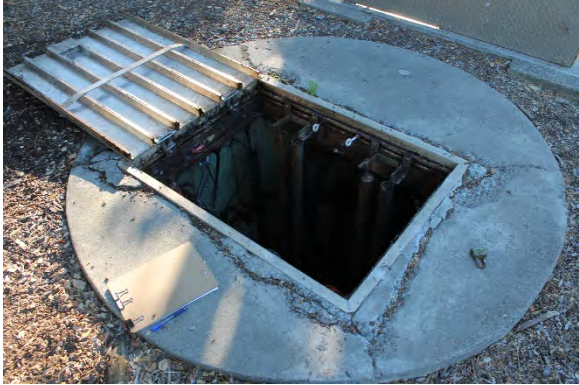
<p>Wet well concrete top cracked and in poor condition. Access hatch in fair condition.</p>

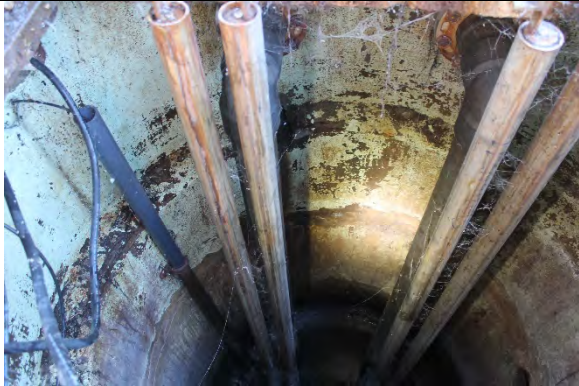
<p>Wet well concrete in fair condition.</p>

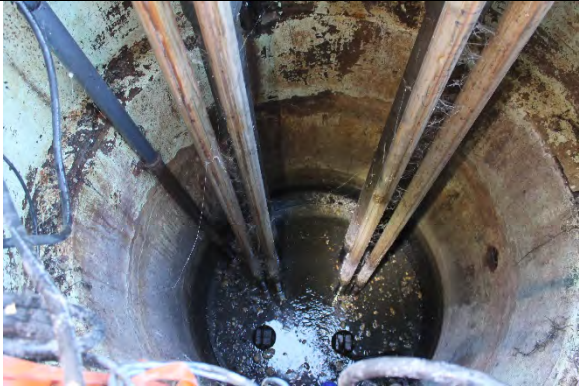
<p>Wet well grout cracking and in fair condition.</p>

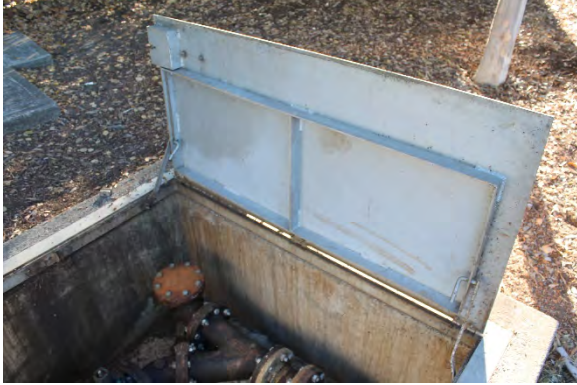
Valve vault concrete and access hatches in fair condition.

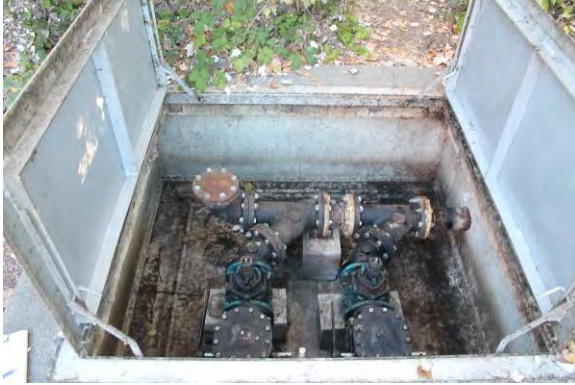
Isolation and check valves are in fair and poor condition, respectively.

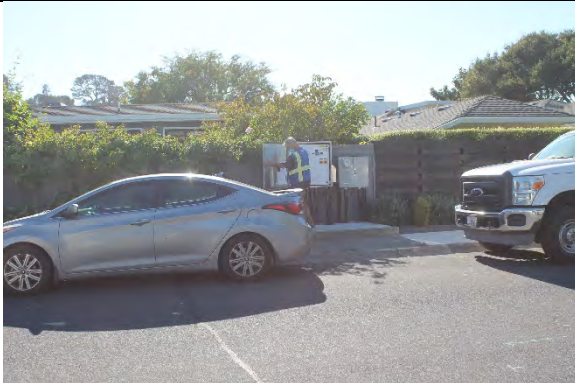
Lift station in fair condition. No access issues.

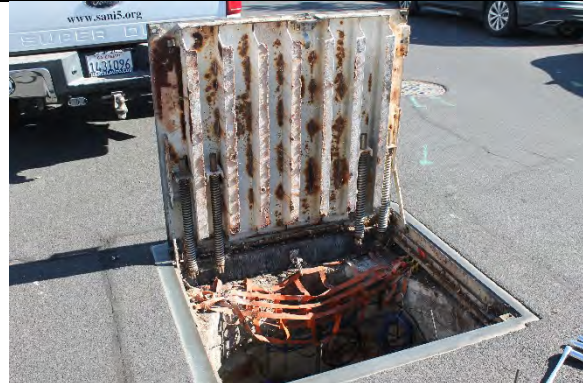
Painted wet well steel access hatch is in fair condition and exhibiting moderate surface corrosion.

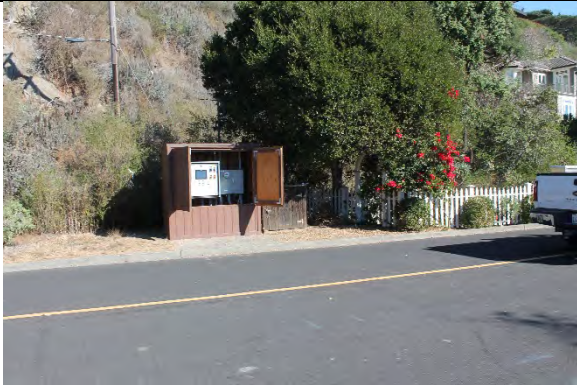
Lift station in good condition. No access issues. Electrical and I&C upgraded in 2018. Backup power provided by portable generator.

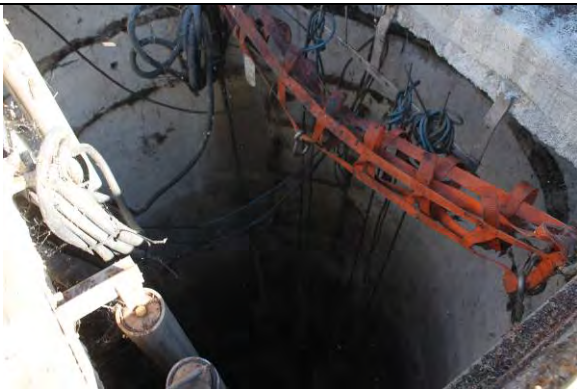
Wet well concrete is in fair condition.

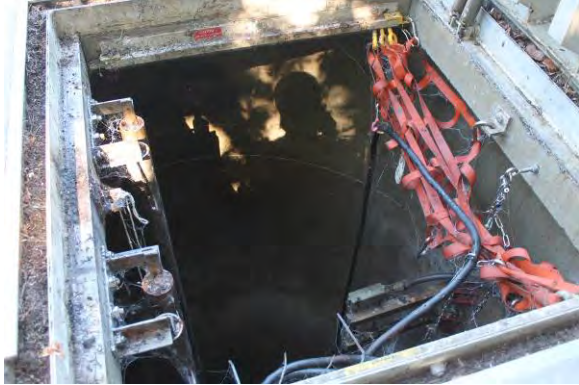
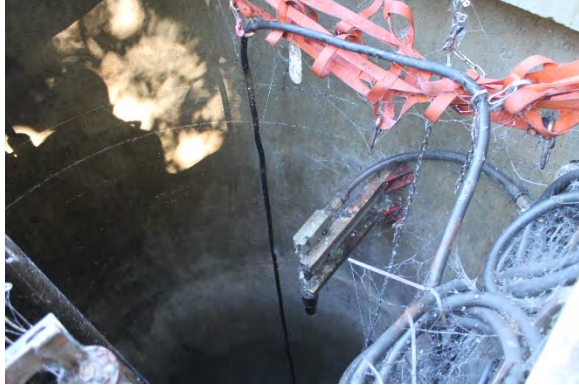
Wet well concrete is in fair condition.	Wet well concrete is in fair condition.

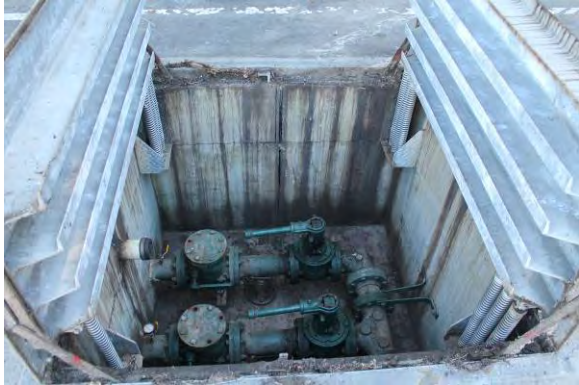
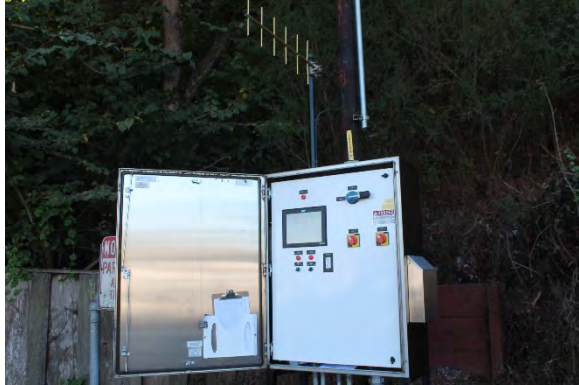
Valve vault concrete and access hatches are in fair and good condition, respectively. The isolation and check valves are in fair condition.	Electrical and I&C recently upgraded and in very good condition. Backup power provided by portable generator.

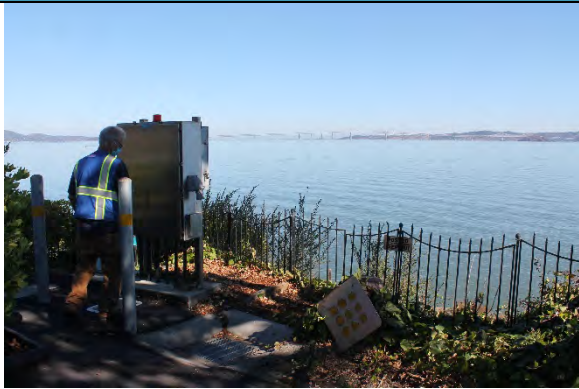
Seafirth 2 Lift Station

<p>Lift station in good condition. No access issues.</p>

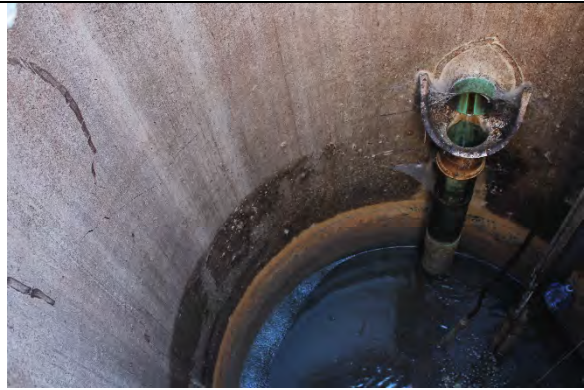
<p>Wet well concrete in good condition.</p>

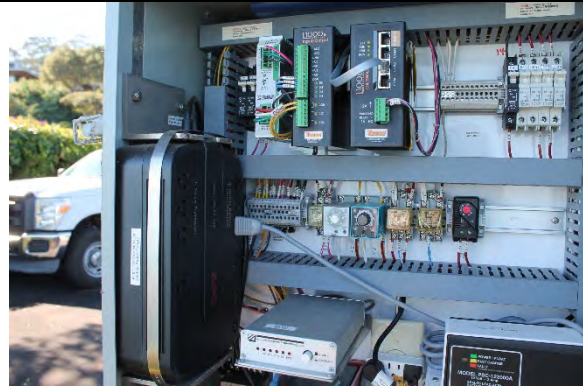
Electrical and I&C upgraded in 2009 and is in good condition.
